MONTHLY REPORT 1

20 August to 19 September 2002

By GGDMA Miners Environmental Officer

GENCAPD Project

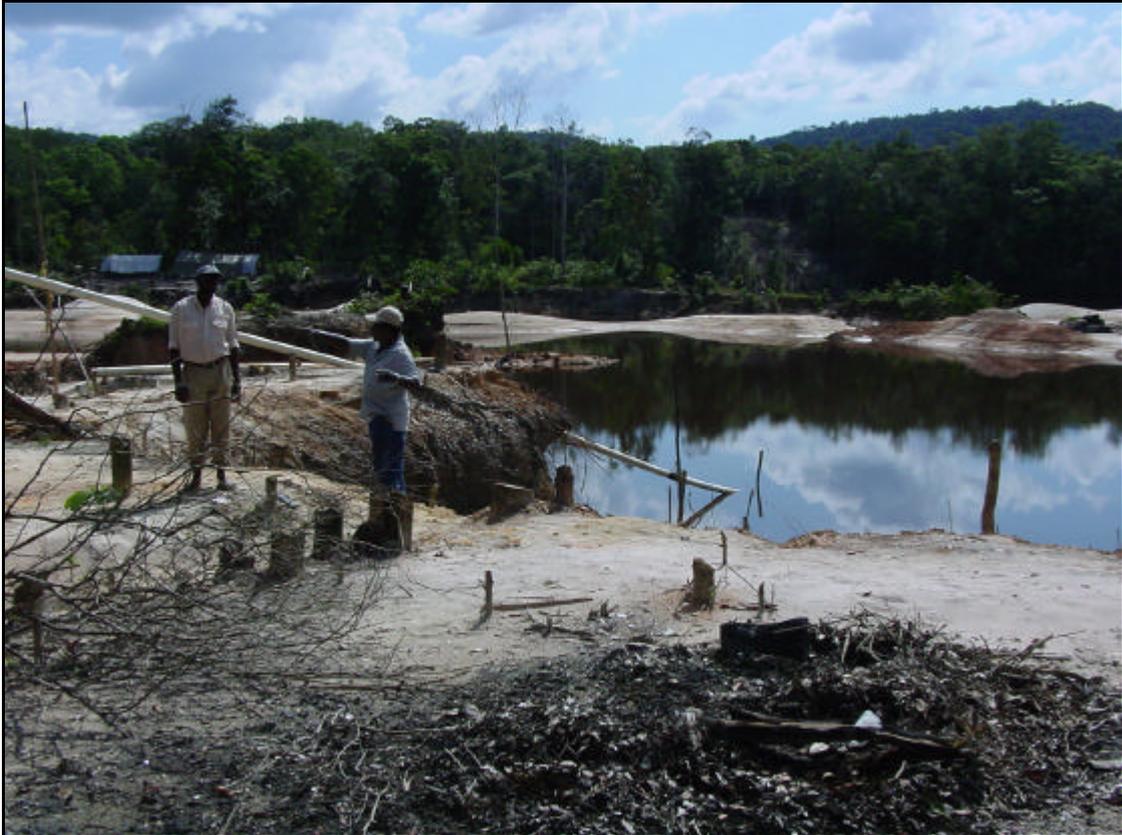
- Most land dredges and all river missile dredges were operating illegally within the 66 feet buffer zone from low water mark going inland (**Plates 1, 2, 3 & 4**).

- Many land dredge operations, through working within the buffer zone (or thereabouts) had open breaches to the Mazaruni River, which caused both productivity* and environmental issues: work pits were rendered unworkable when river waters flooded in to them on occasion and highly turbid waters (a mixture of loose soil from unstable work pits and 'sling' water [tailings] from sluice boxes) were draining directly back out to the river, once the high waters had receded and water was flowing out of the pits through the breaches (**Plates 1 & 2**). [**Water management on-site in the work pits is crucial to productivity and therefore, operations too close to the river run the permanent risk of bank breaches and reduced productivity.*]

Plate 1: Most land dredge operations are mining right on the river bank. The regulation 66 feet buffer zone is ignored resulting in breaches to the open river channel (In some cases, these breaches are facilitated by river dredges making further in roads onto land claims). In this case (**Tyron Powers** claim) new and old work pits have been flooded by the rising waters of the Mazaruni River, allowing for the escape of fine tailings directly to the river. Old pits, even if they are being used for backfilling are not isolated from the river, and as such there is little or no settlement of fine material prior to discharge back to the river. **Wilton Tafares** (General Manager) discusses tailings management with GGMC staff.

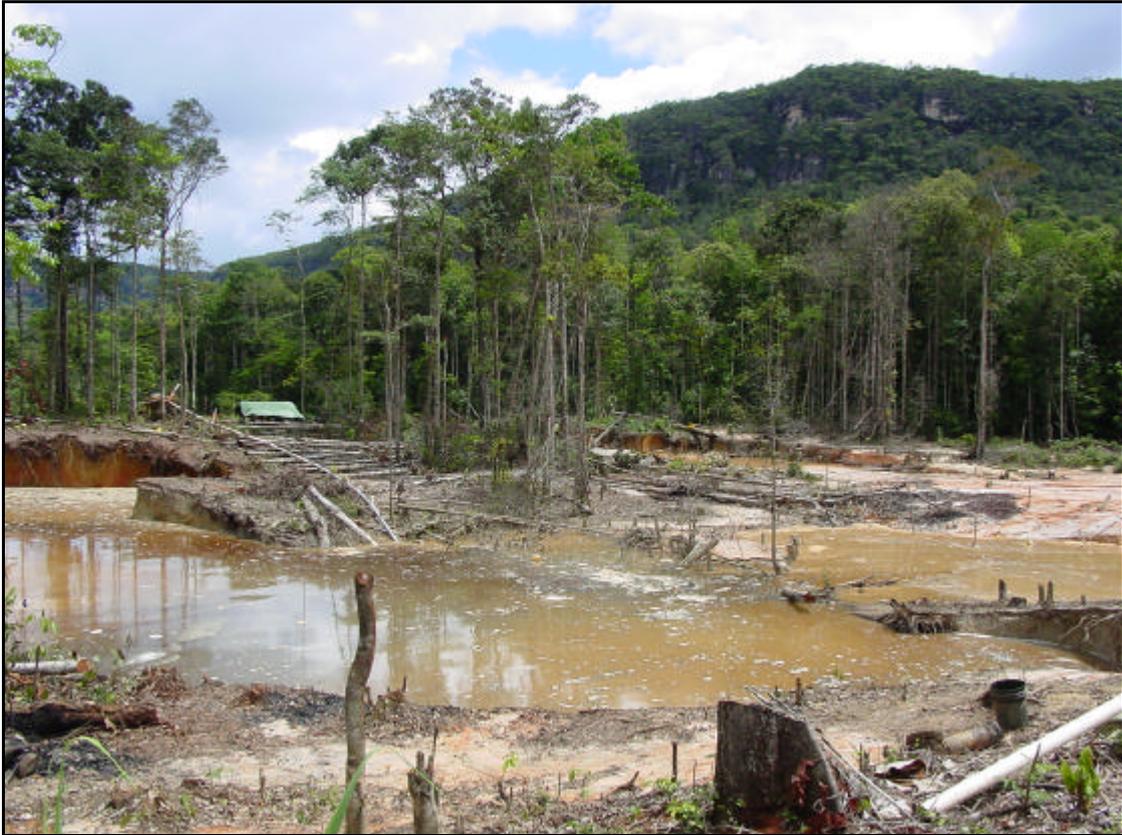
Plate 2: Flooded work pits (old and new) within the 66 feet river bank buffer zone. Turbid water, being a mixture of both tailings discharge and loose soil from the actual work pits, escapes easily and directly, once the high water levels subside. In this case (**Buddy Henry** and **Philbert Moore** claims, Upper mazaruni, upstream from Imbaimada) work had to cease, and after river levels subsided, the remaining turbid water that could not drain back to the river channel, had to be pumped. In the absence of suitable old pits and tailings retention and settlement ponds, this turbid pit water is pumped and ejected directly into the river.

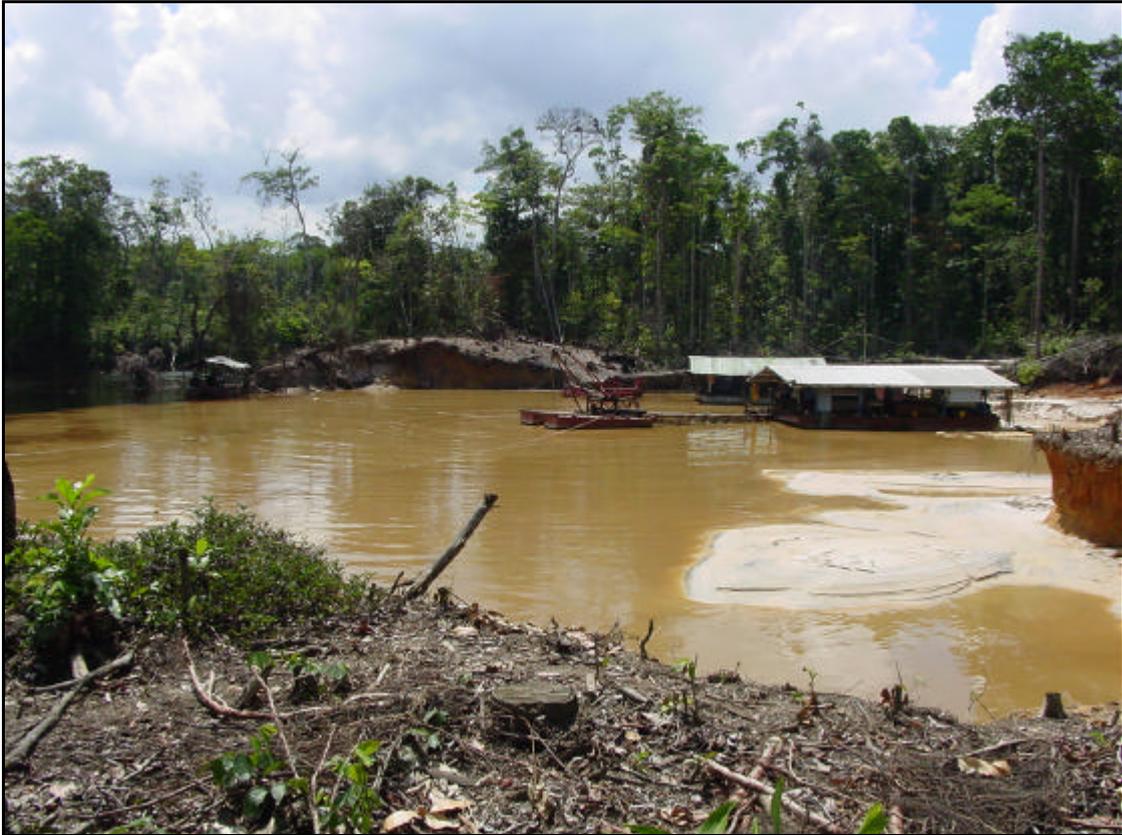
Plate 3: River dredge clearly operating illegally inside the river bank and within the 66 feet prescribed buffer zone. Tailings are dumped on the land side of the breach, however, with the bank fully breached this highly turbid zone is free to mix with the passing waters of the Mazaruni River. In this case (**Mark's** claim, upstream from Imbaimadai) two missile dredges are blatantly contaminating the Upper Mazaruni River.

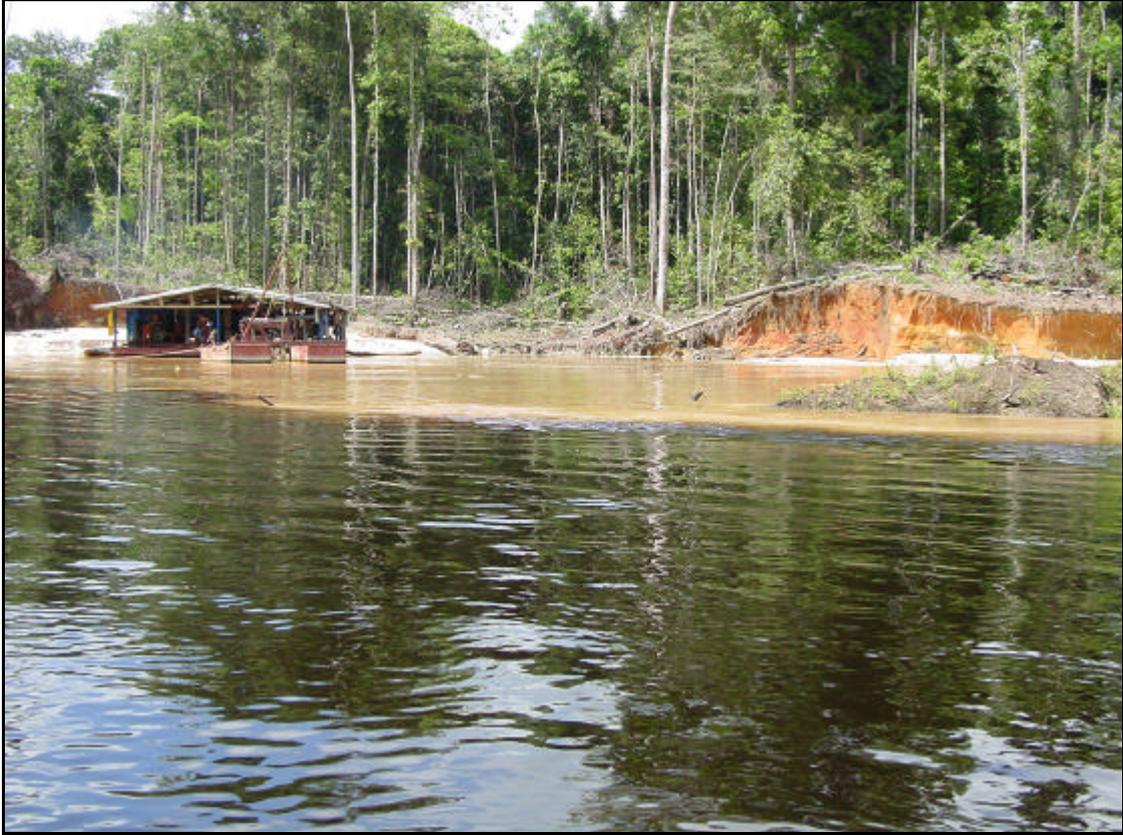
Plate 4: As in *Plate 3*, missile dredge inside a large and penetrating breach into the river bank, with turbid waters escaping freely to the Upper Mazaruni River (**Mark's** claim).

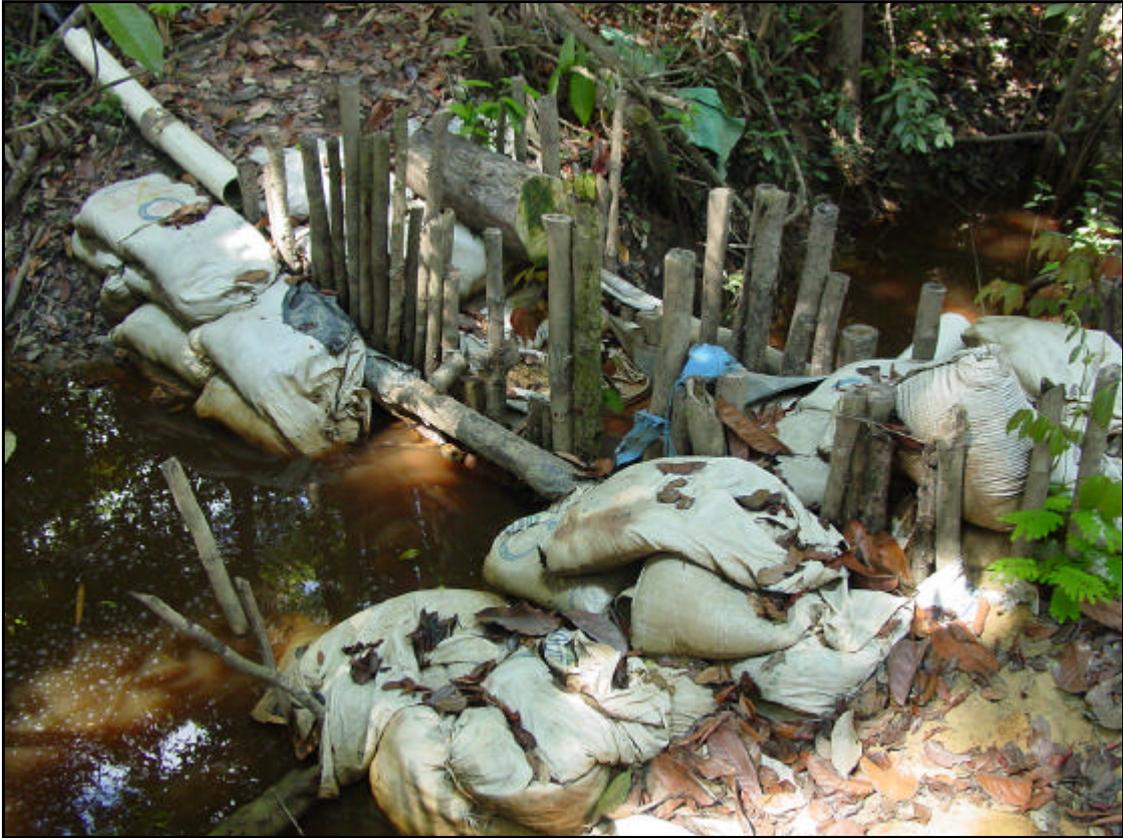
- Most dams were constructed very poorly from sand bags and organic material (small tree trunks, sticks and leaves), and were no longer considered capable of retaining tailings (**Plates 5, 6 & 7**).

Plate 5: Ravine dam holding back tailings from old suction dredge pit just behind river bank on the Upper Mazaruni, upstream from Imbaimadai. Discharge pipes and some bags were removed in the attempt to allow backed up water to escape to river. As a result this dam's structural integrity has been compromised. Overall these ravine dams, as a means to managing tailings (i.e. preventing tailings entering river through provision of adequate storage and settlement time), are short-term remedial solutions. (**Tyron Powers** claim)

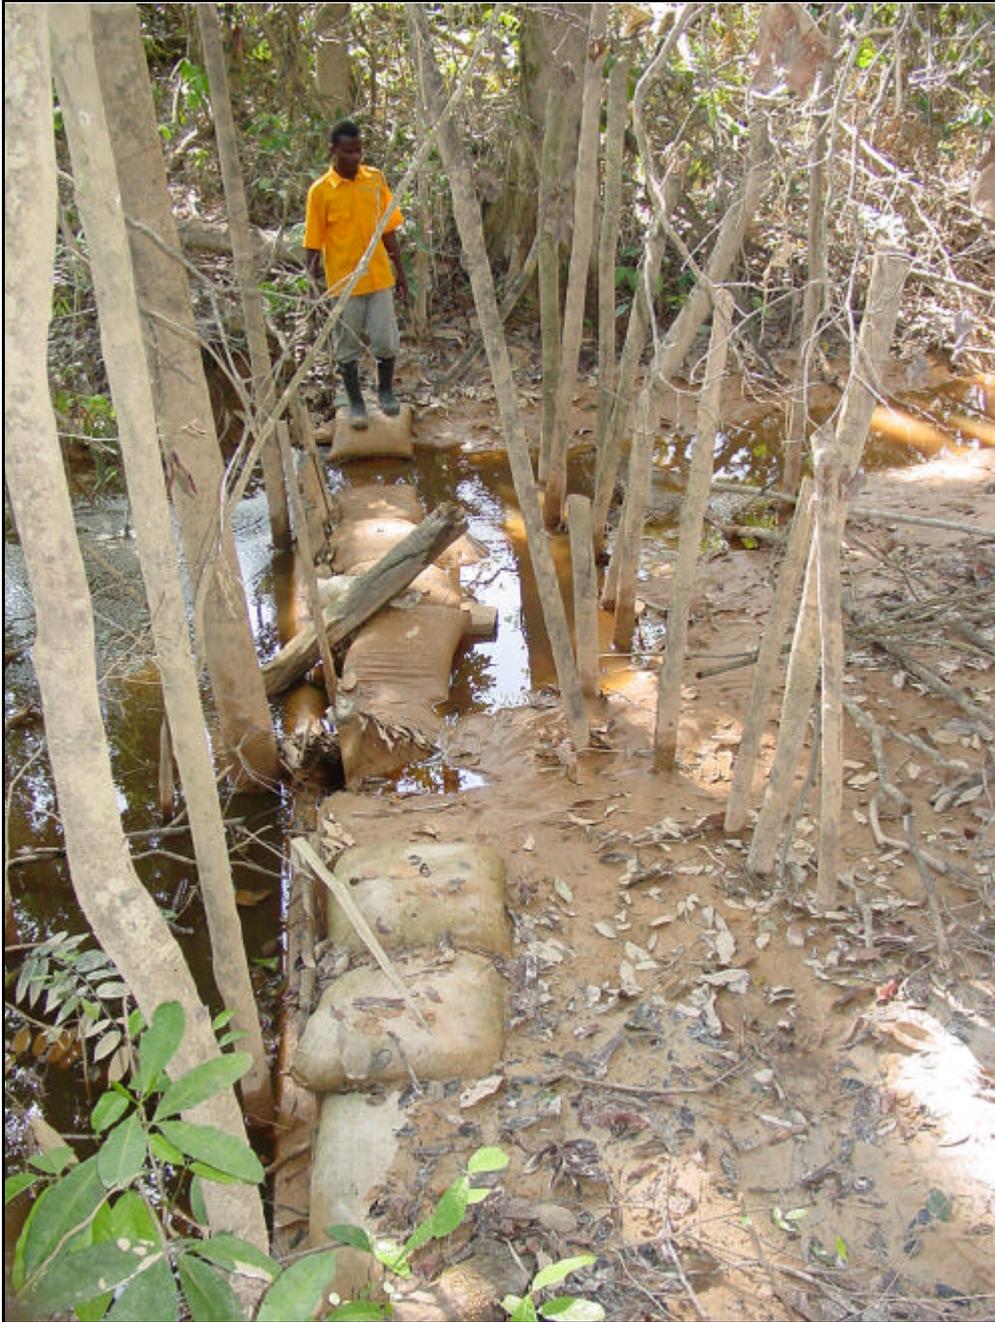
- The hydraulic profile of the ravine micro-catchment is dramatically altered, leaving unanswered questions as to how localized floodwaters will flow back to the river, now that their normal path, the old ravine drainage line, is completely full up with tonnes of tailings.

Plate 6: Ravine dam (Tyron Powers claim, Upper Mazaruni, upstream from Imbaimadai) completely filled beyond useable and safe capacity. Natural drainage from the riverine ecosystem's natural micro-catchment is from right to left in the photograph. With the natural hydraulic profile of the ravine now changed, it is only a matter of time before the medium to course tailings is released into the river channel. The fine material has already all escaped to the river, because since there is no freeboard holding a minimum retention volume of water, there is no room for adequate settlement of the fine colloidal material.

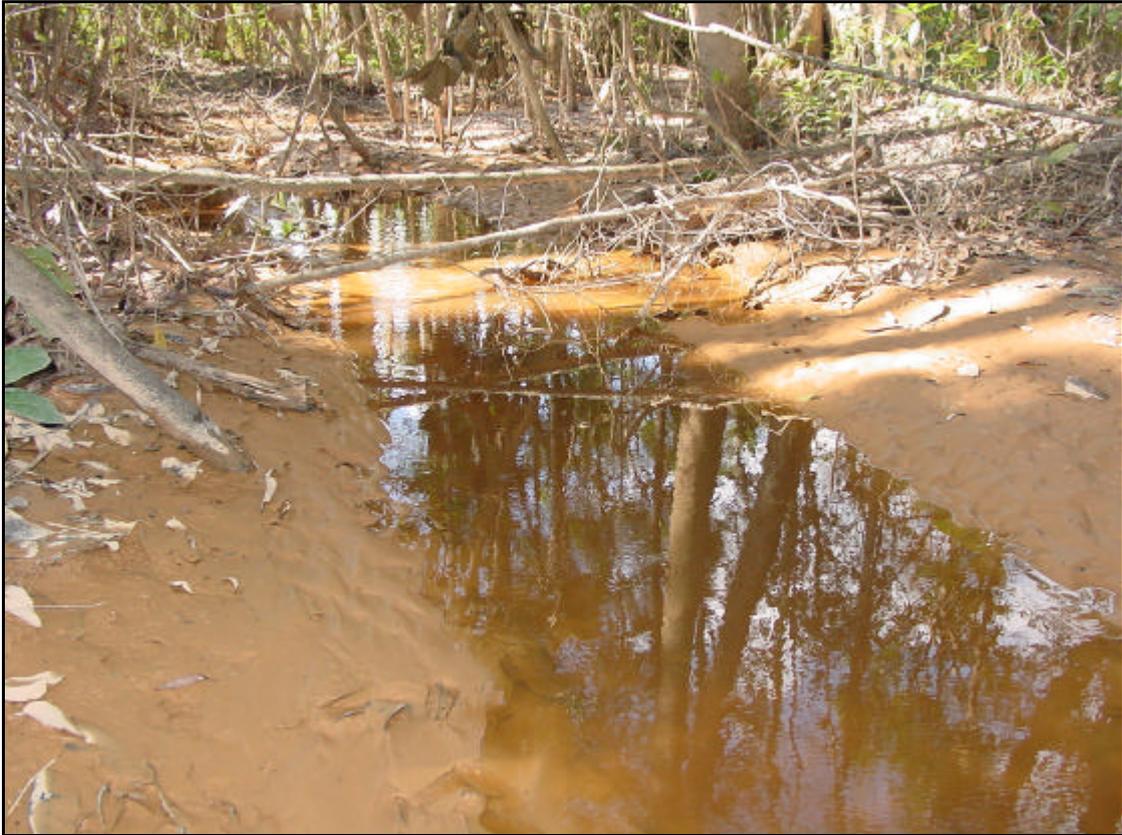
- The tailings held back inside these ravines, will at some point in the future make their way into the main river channel, as the micro-catchment, which drains into these ravines, continues to be active well after the 'decommissioning' of the mine.

Plate 7: Effect of damming of ravines. Tailings completely fill what was once a narrow deep natural drainage channel. In this case (**Tyron Powers** claim, Upper Mazaruni, upstream from Imbaimadai) the natural baseline water flow, flowing toward the viewer, is continually carrying fine material to the ravine dams constructed (*Plate 6*), and which, being now filled to beyond capacity, permit the constant discharge of tailings into the river. What are the other effects of this change in hydraulic profile?

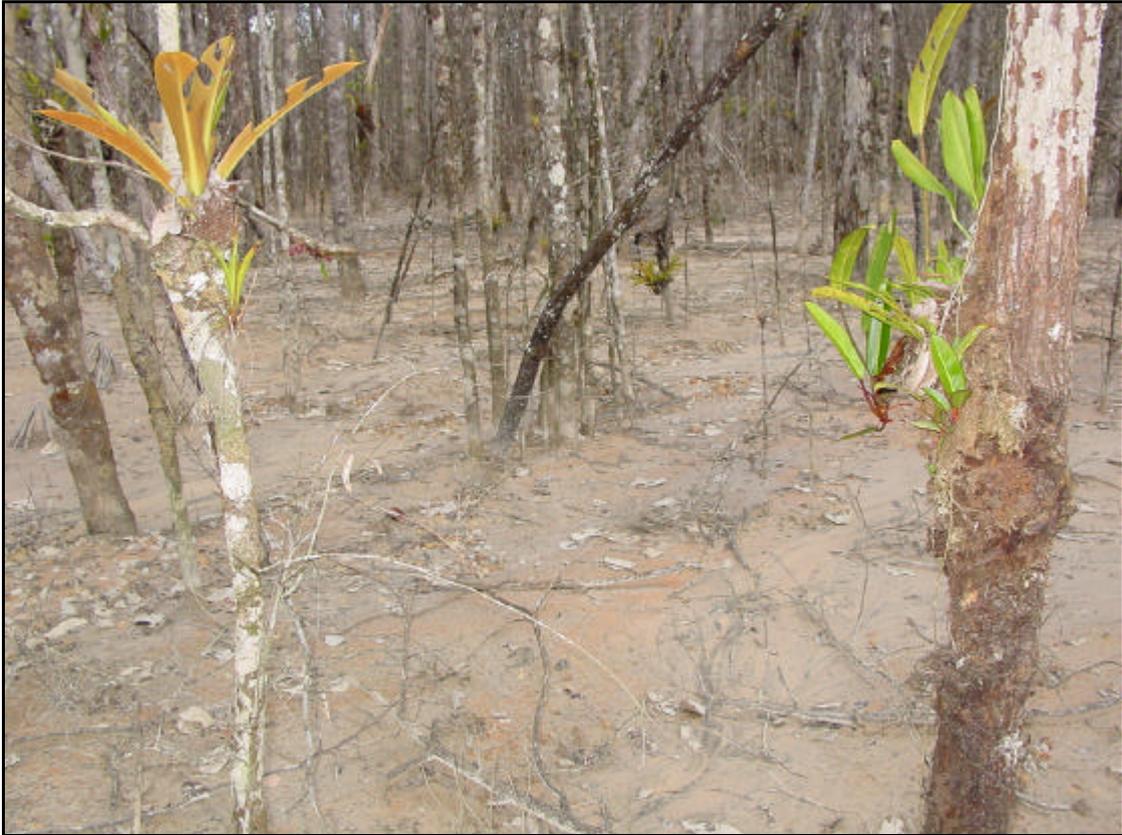
- Tree death in upstanding forests takes up to 6 months. This slow death is due to tailings covering the forest floor stopping normal humus decay. Since tropical forest soils are generally nutrient poor, the humus layer plays a vital role in providing organic nutrients to the forest trees and shrubs. Once covered over by tailings the bacterial and fungal decay processes, which make these nutrients available in the humus layer, are seriously restricted (**Plate 8**).

Plate 8: Once the forest floor's humus layer is covered over with tailings, tree death takes up to six months (pers.comm. Amerindian dredge owner, Wariquima). Analogous to partial suffocation, without a source of nutrients the trees, despite continued solar energy, die a slow death. Vital bacterial and fungal decay processes in the humus layer, which liberate essential nutrients for uptake by the shallow rooted plants, are stopped once air and light are restricted by the covering layer of tailings (**Tyron Powers** claim, Upper Mazaruni River, upstream from Imbaimadai).

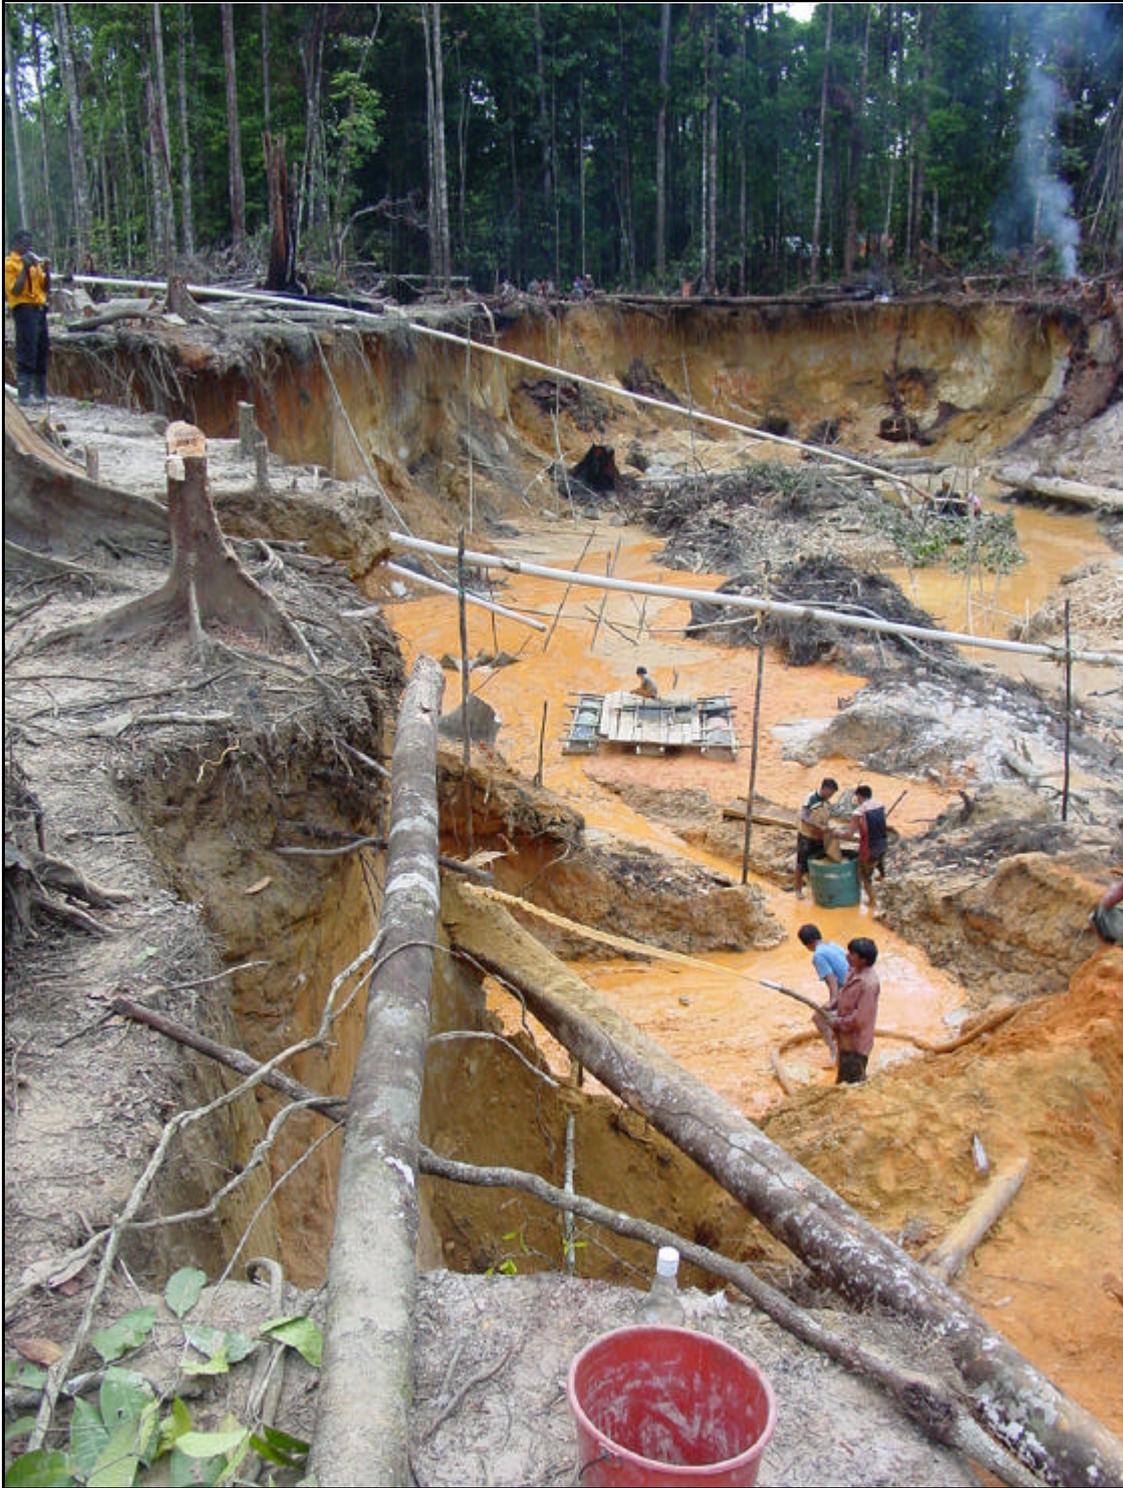
- Miners are generally very open to awareness-raising workshops, environmental education and technical assistance in tailings management.
- Land dredge operations on Amerindian concessions, pose additional social issues, with many non-mining personnel present on-site (**Plate 9**).

Plate 9: Four dredges operating in the same large work pit (**Wariquima Amerindian concession**, Upper Mazaruni, Jawalla). Note the presence of children in the active work pit. All tailings generated flow into large back swamp immediately behind river bank, some 900 metres from this pit.

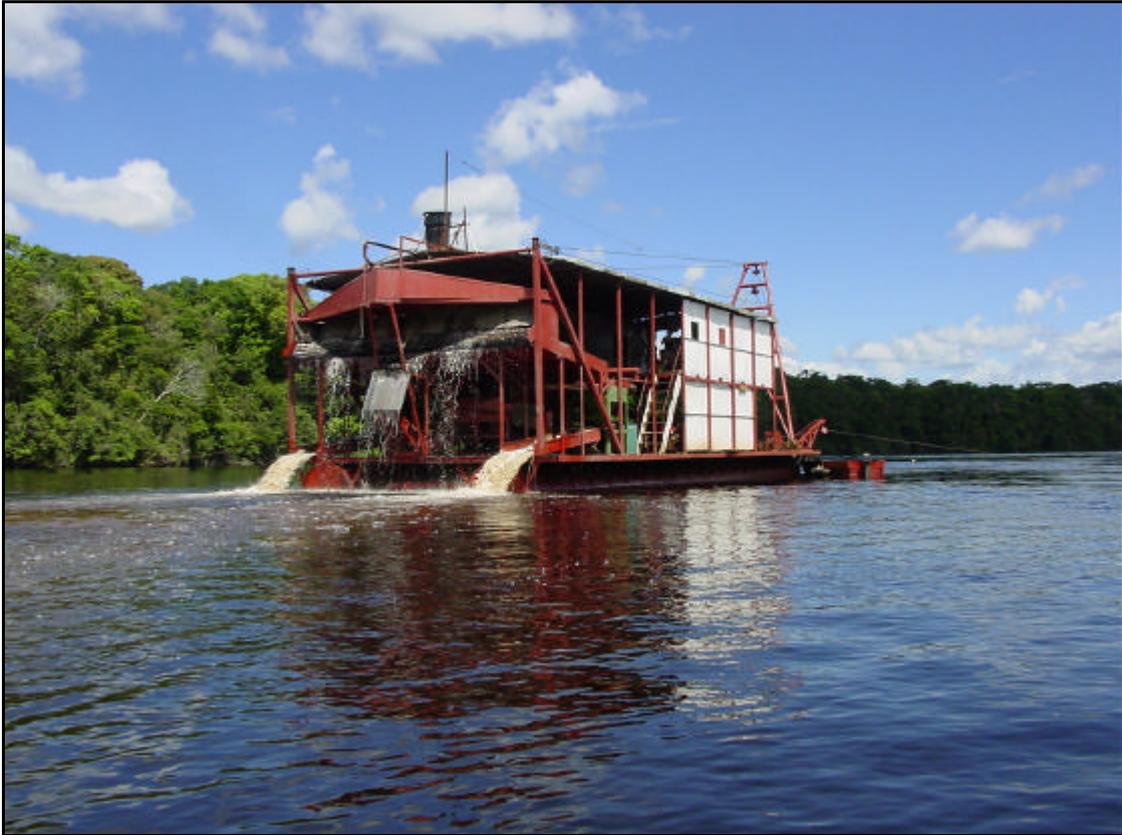
- The floating river dredges (cutter suction type) have a lower environmental impact in terms of overall river turbidity than the land dredge operations (**Plates 10 & 11**). "Most rivers and streams flood on a regular basis. What makes suction dredging unique is that it takes place in a very dynamic environment...a natural stream or river. Natural variations in stream conditions, such as continual downstream movement of material through erosion and flooding, cause the effects of small scale suction dredging to be very local and short term. Suction dredging simply mimics natural erosion on a very small scale. Areas that have been subjected to years of suction dredging show little sign of the activity. During floods, impacts similar to those caused by suction dredges occur on a vastly wider scale. It is now believed that the regular movement of sediment in a stream is vital to its health, much as forest fires have come to be seen as a vital part of the life-cycle of a forest. The life in and around a stream or river not only is not hurt by irregular turbidity and rechannelization effects, it has evolved to need these events to occur periodically for the environment to remain healthy. A major threat to the health of many streams is now seen to be the construction of dams. Many of these dams were originally built to help control flooding. Now it is seen that this has actually led to damage to the ecosystems of these streams. This new research sheds new light on

Plate 10: Cutter suction floating river dredge: Brazilian built, owned and operated (13 kms downstream from Kamarang, Upper Mazaruni River). Low colloidal content in river bed material means that tailings turbidity discharge is significantly less than that from land dredges. The main environmental impact noted here is the creation of artificial sand/gravel bars mid-stream, increasing navigational risk to boat operators. (See Page 3 for comments regarding river suction dredging and the natural flood dynamics of river hydraulics)

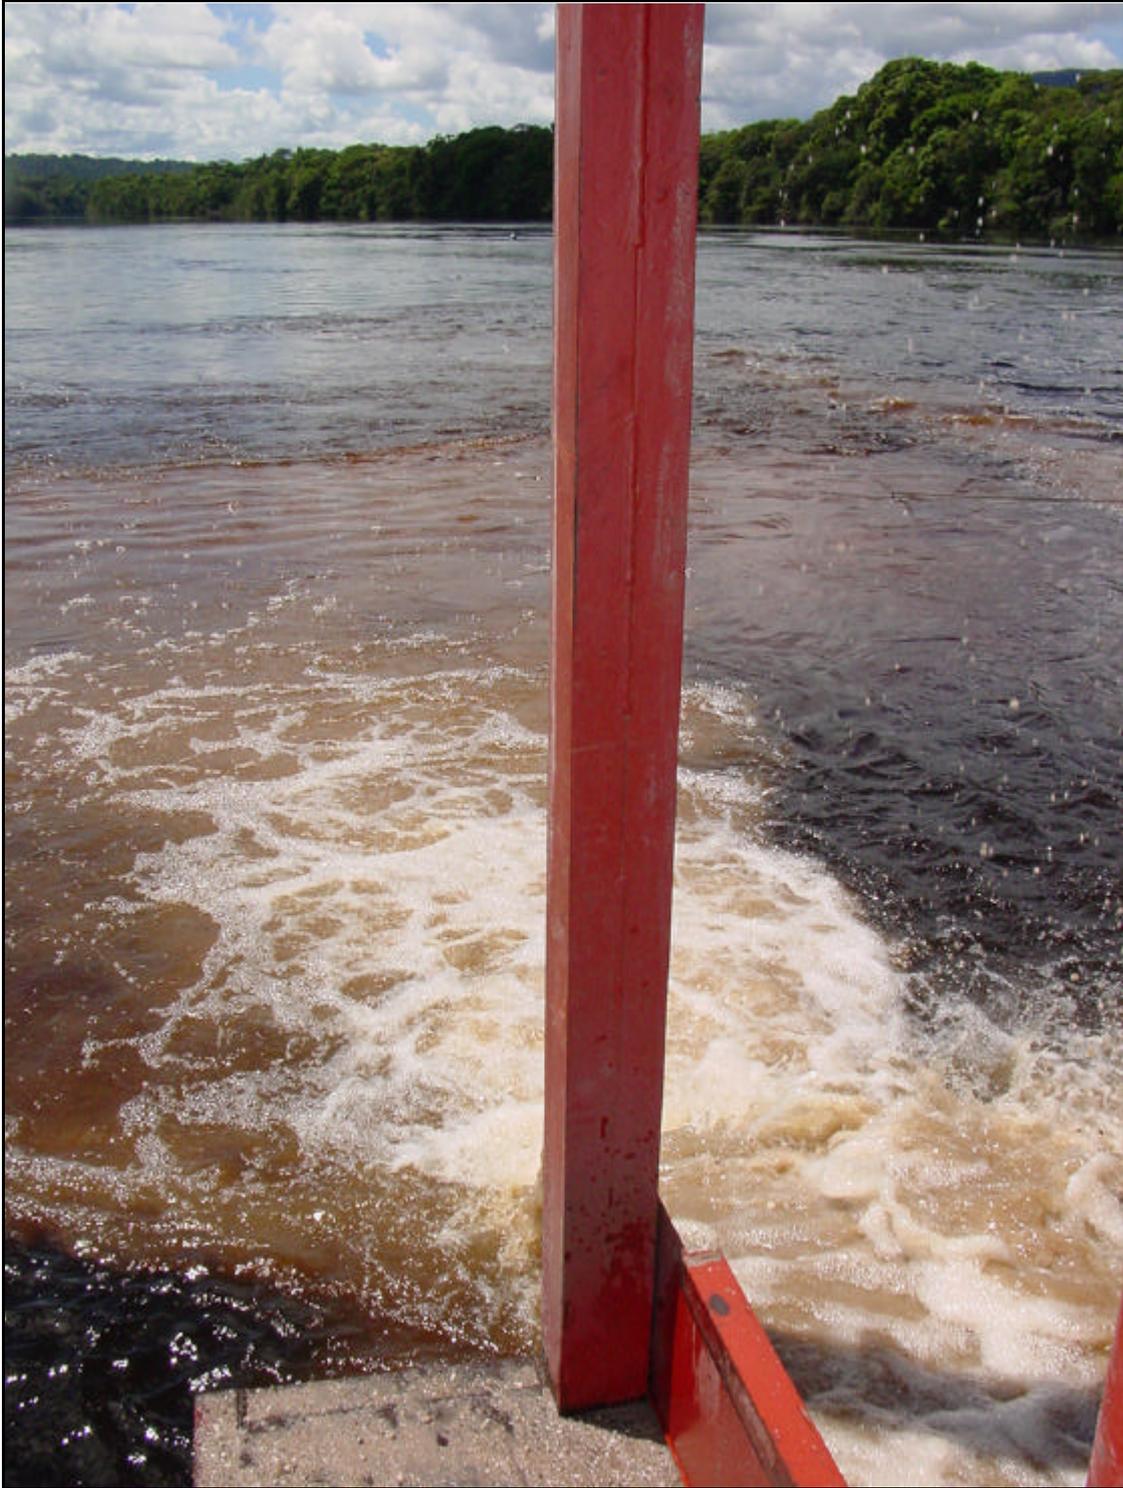
Plate 11: Cutter suction floating river dredge (Brazilian operation, 13 kms downstream from Kamarang, Upper Mazaruni River) with tailings discharge directly into midstream channel.

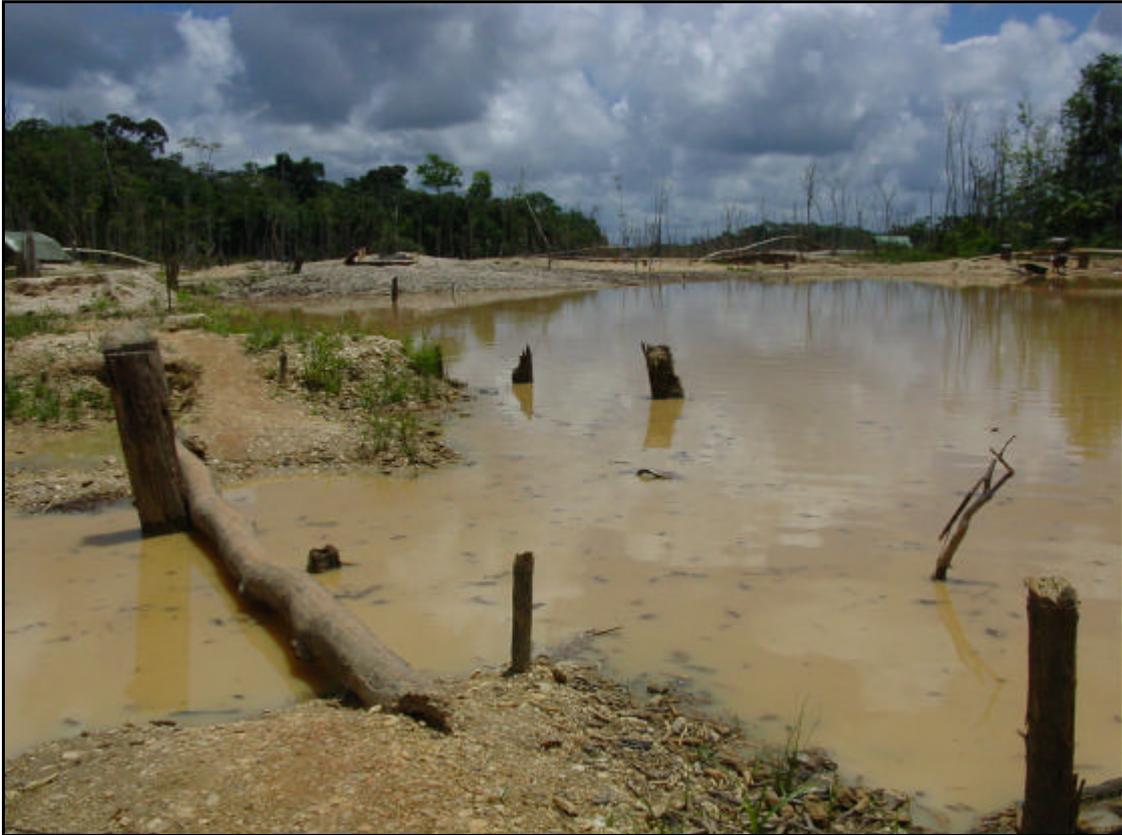
- The entire Arakaka river flat is a completely altered environment:
 - The creek no longer flows along its original channel
 - All old pits are inter-connected and the creek flows freely through them, thereby preventing any colloidal settlement (**Plate 12**)

Plate 12: Arakaka Creek back dam, NWD. Arakaka Creek flows through old pits. There is no isolation of tailings for retention and settlement purposes. All colloidal material remains in suspension through a combination of movement and dilution effects created by river flows mixing with tailings waters. Photo taken mid-way along Arakaka Creek flats.

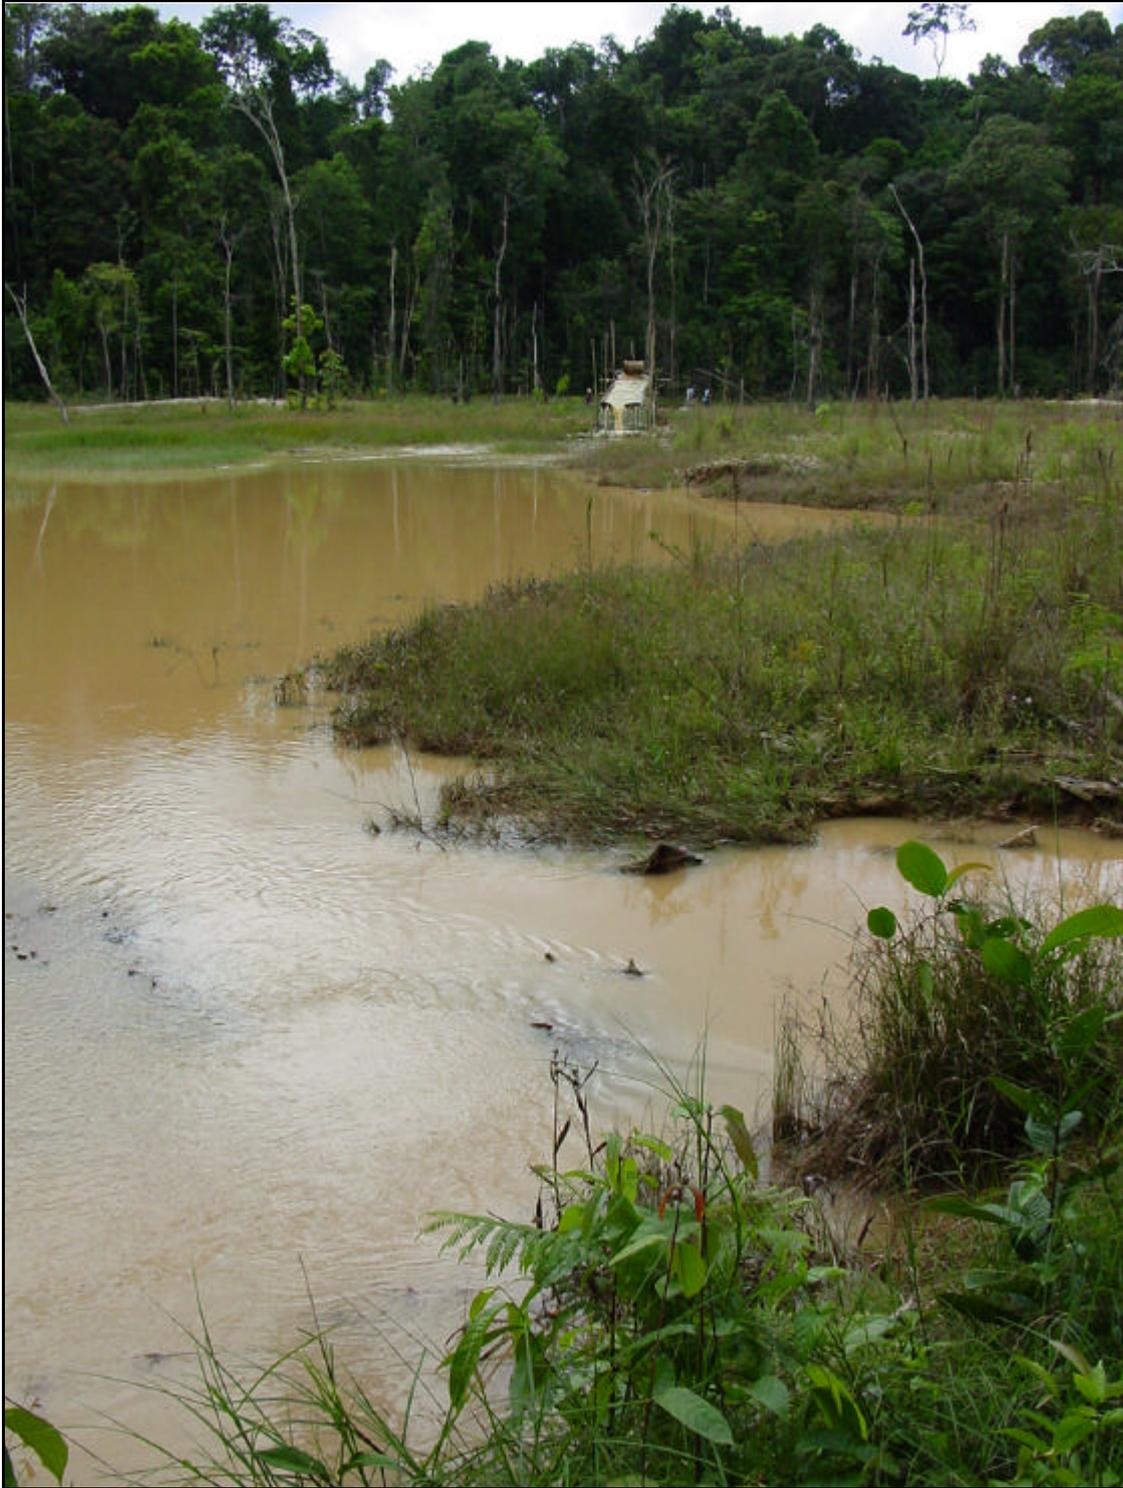
- All sluice boxes dump directly into the flow of the creek (**Plate 13**)
- There are too many dredges operating in a confined area. Estimates of 40-50 dredges have been made for Arakaka back dam. This in itself creates issues:

Plate 13: Arakaka Creek back dam, NWD. Sluice box discharges directly into creek flows. The creek has been diverted continuously and no longer flows in its original channel. This is the fifth dredge operation from the top of the creek flat operations (**James Lowe** claim).

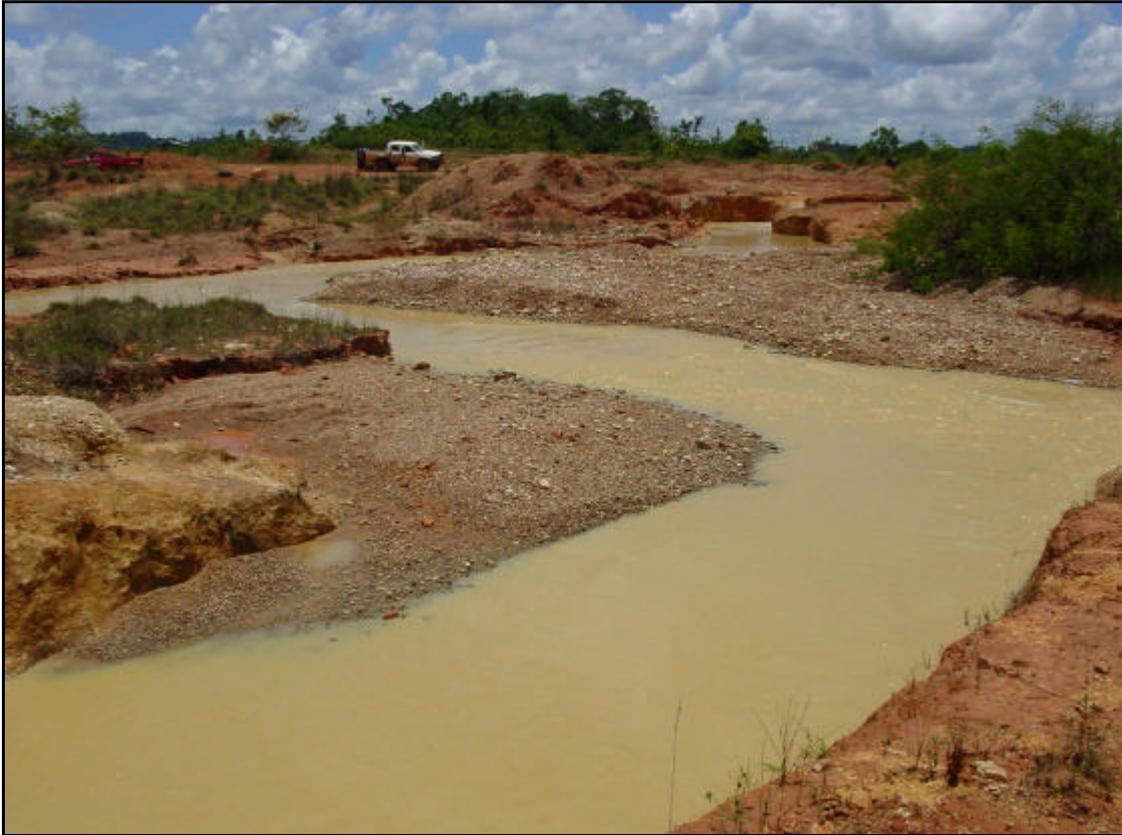
- Some dredge operators lower down the creek flat have attempted to redirect the river by isolating it from the rest of the operations and the old pits (**Plate 14**).

Plate 14: Arakaka Creek back dam, NWD. Attempts at using earthmoving equipment to isolate creek from active operations and to prevent the water from flowing through old pits, which are being used as tailings ponds. This is the work of only one operator (**Rodrigues** claim). These waters have drained through all the old pits of claims upstream and will continue to do so once this water leaves this claim heading downstream. Arakaka Creek starts off at 10 NTU upstream of the topmost dredge (see *Plate 15*). At the point just before it discharges to Barima River, the turbidity reading is 4000 NTU!

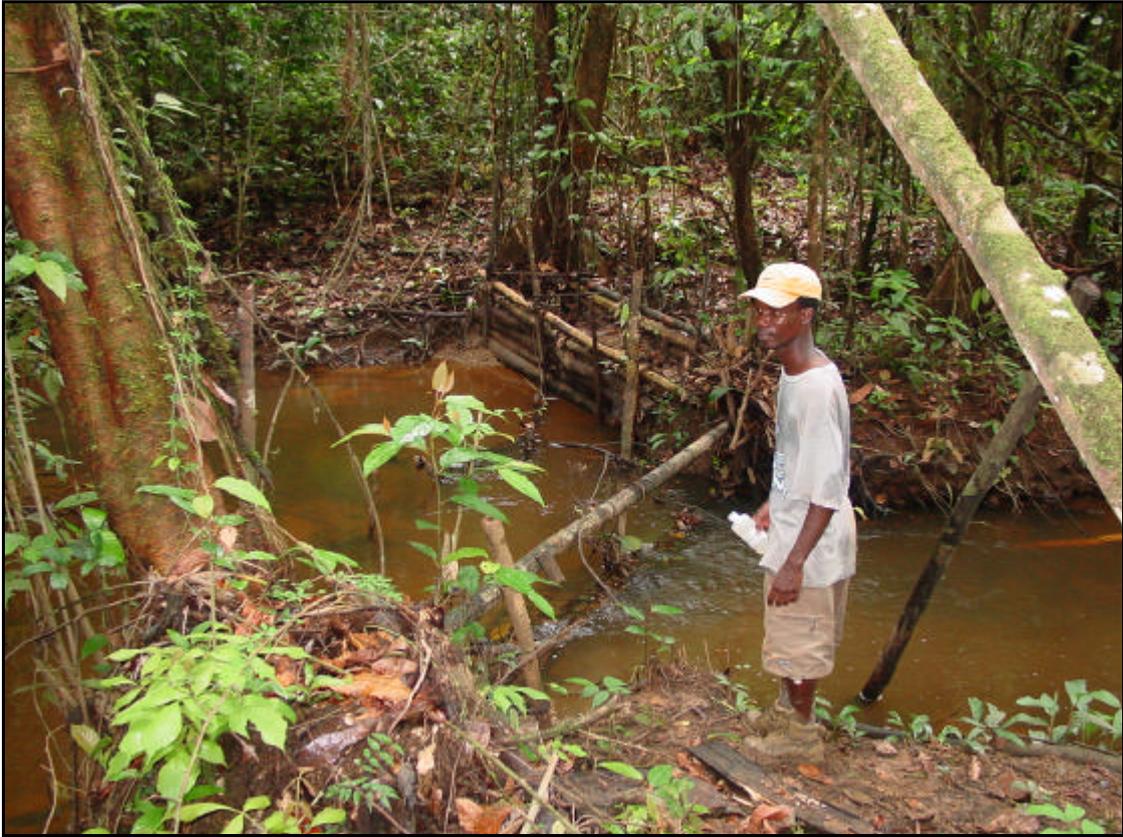
- Damming of the existing creek flow has the danger of backing water up and flooding neighbouring claim owners topside.
- Upstream of the top-most dredge, Arakaka Creek has a turbidity reading of **10 NTU** (**Plate 15**). Downstream of the first dredge the reading is **150 NTU**. By the time Arakaka Creek flows into the Barima River, it has a reading of **4000 NTU!**

Plate 15: Arakaka Creek back dam, NWD. Arakaka Creek upstream from topmost dredge with a low turbidity reading of 10 NTU.

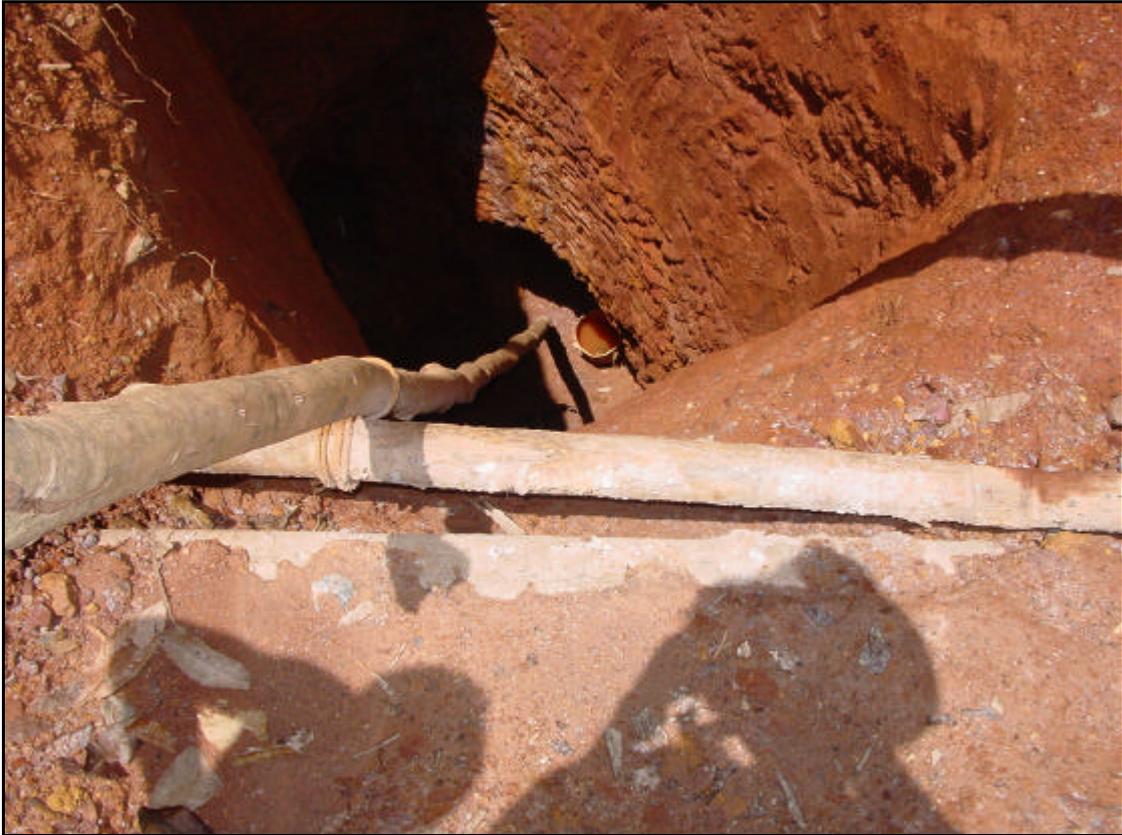
This was an unplanned visit to a back dam, one hour's walk from the Port Kaituma-Barima Road, in order to view hand dug shafts following secondary gold enrichment through quartz veins in a dark red/purple saprolytic parent material. See **Plates 16, 17 & 18**.

Plate 16: 10 Mile Back dam, Port Kaituma-Barima Rd. Open hand-dug shaft, mining secondary gold enrichment through quartz veins in saprolytic parent material (**John & Clarence Rodrigues** claim). Saprolyte carried to the surface, crushed and washed through the sluice.

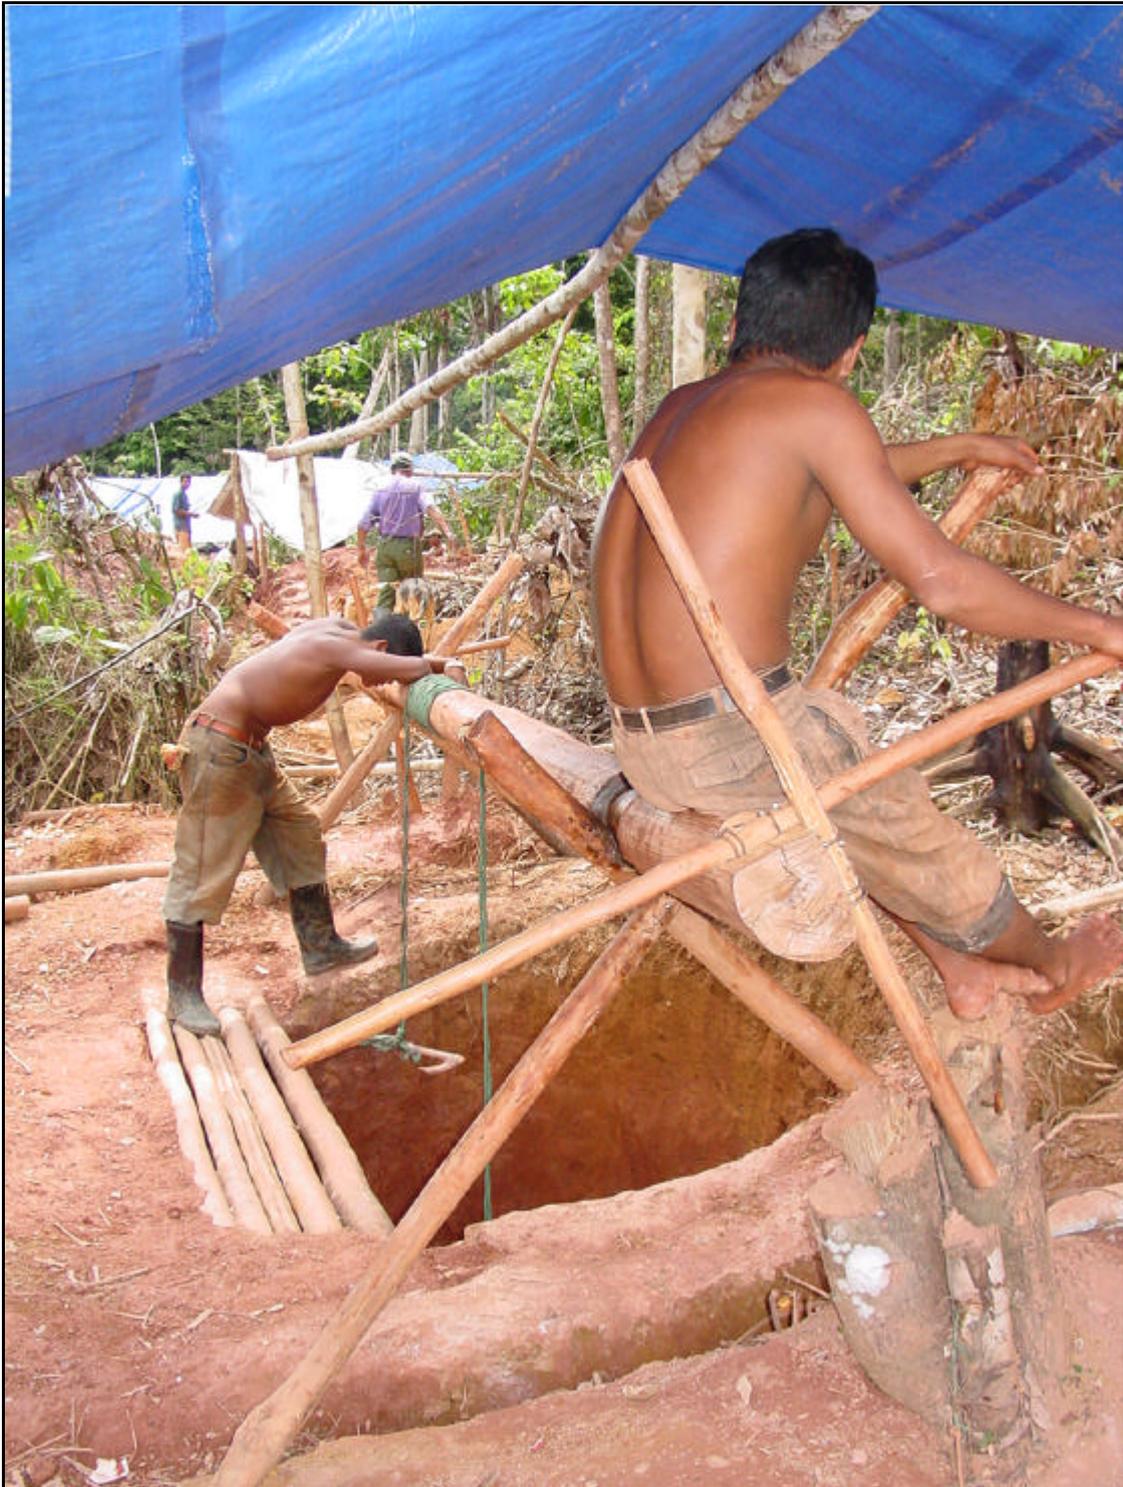
Plate 17: 10 Mile Back dam, Port Kaituma-Barima Rd. Open hand-dug shaft, mining secondary gold enrichment through quartz veins in saprolytic parent material (**John & Clarence Rodrigues** claim).
