MONTHLY REPORT 1

20 August to 19 September 2002

By GGDMA Miners Environmental Officer

GENCAPD Project

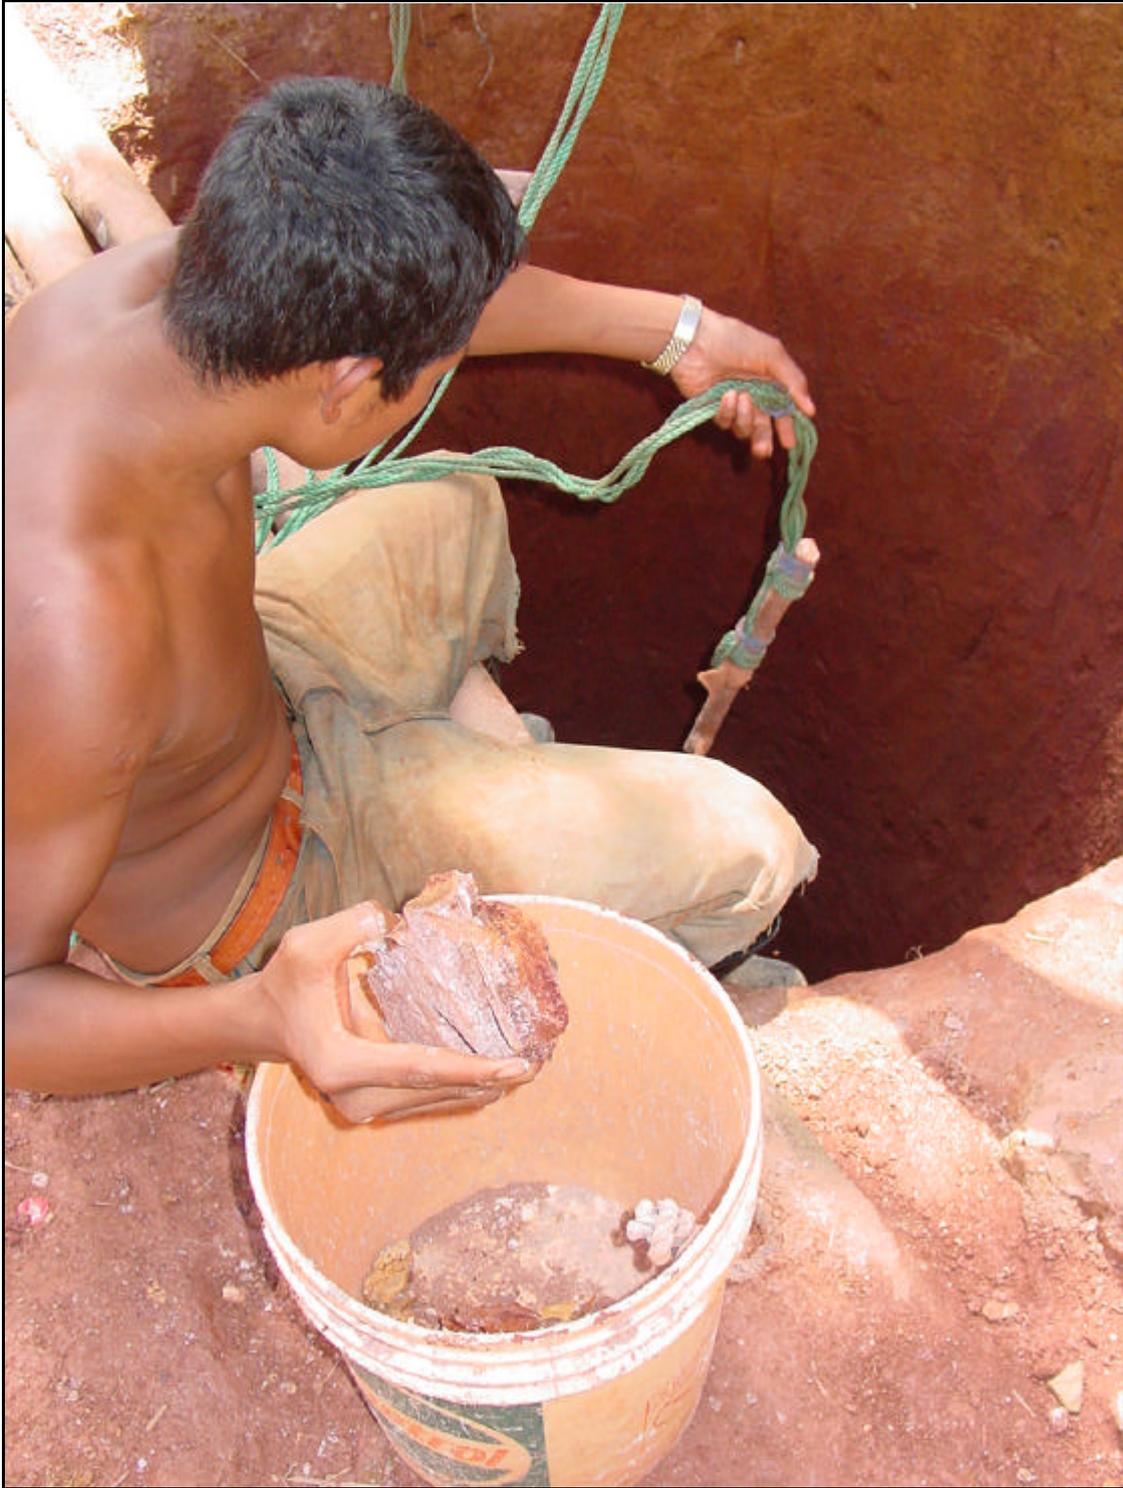
This was an unplanned visit to a back dam, one hour's walk from the Port Kaituma-Barima Road, in order to view hand dug shafts following secondary gold enrichment through quartz veins in a dark red/purple saprolytic parent material. See **Plates 16, 17 & 18**.

Plate 18: 10 Mile Back dam, Port Kaituma-Barima Rd. Open hand-dug shaft, mining secondary gold enrichment through quartz veins in saprolytic parent material (**John & Clarence Rodrigues** claim).
