**GENCAPD PROJECT**

**MINERS' ENVIRONMENTAL OFFICER'S REPORT**  
**On**  
**FIELD TRIP TO KURUPUNG-EPING MINING AREAS**  
*08 October to 22 October 2003*

**By**  
**Lloyd Stephen**

**November 2003**  
**Georgetown**

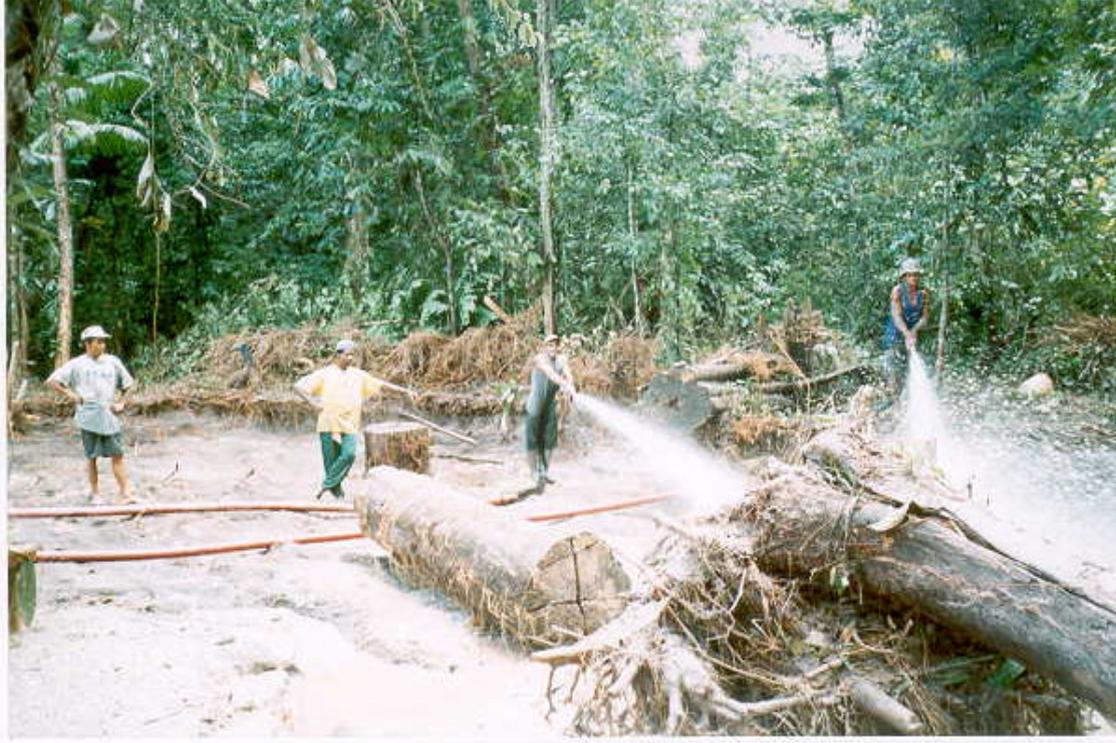
**Photo 1** – Relatively Clean, Orderly and Shallow Mine Pit of Antonio DaSilva’s Operations at Barlow.

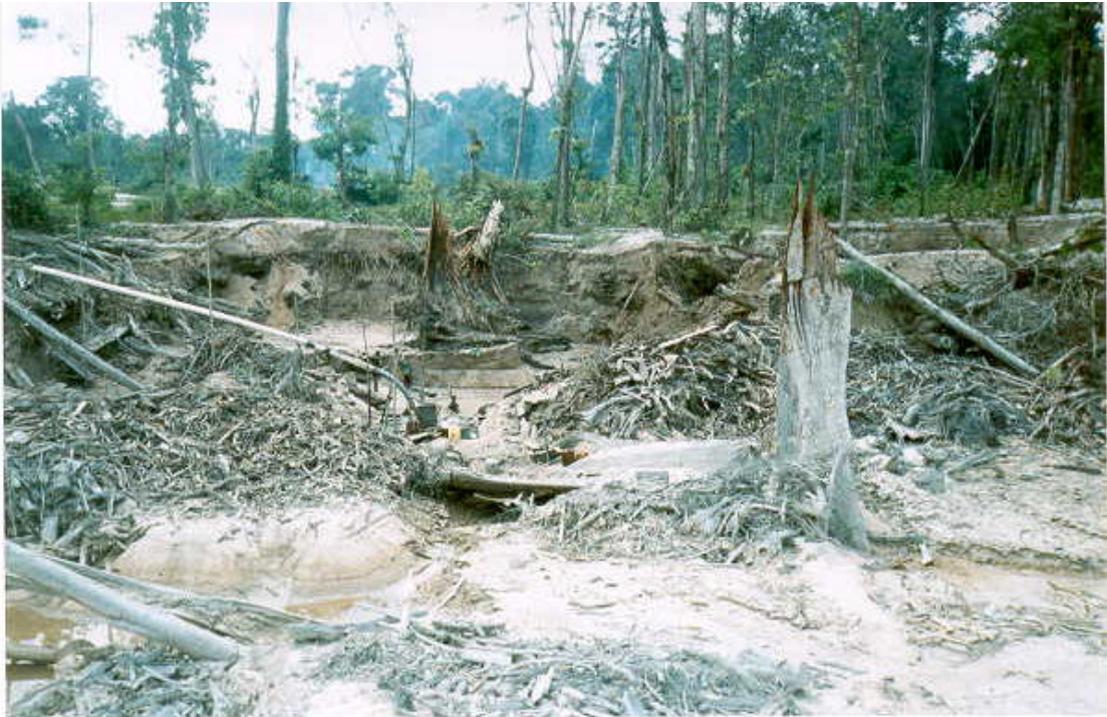
**Photo 2** – Mine Pit at Middle Takuba, Kurupung worked by Bruce Hodge and Neil Fraser. Predominantly Sandy Overburden and Pay Material.

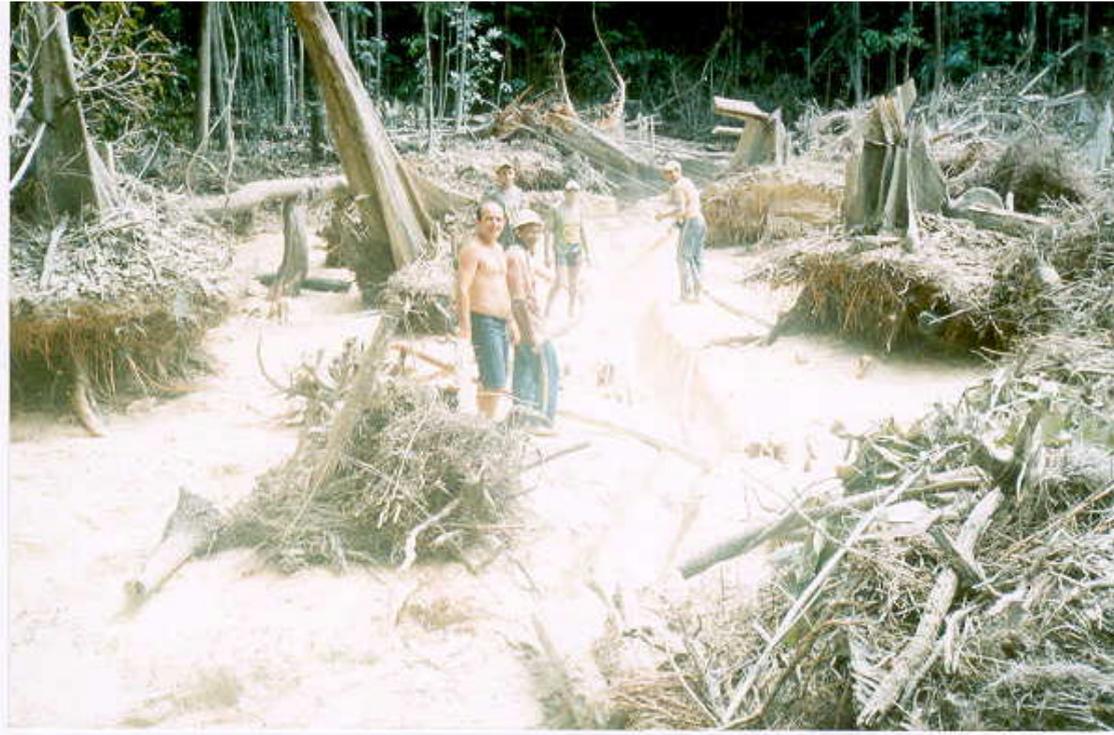
**Photo 3** - Unique Land Dredging Operation (by Carlos DeAguiar at Barlow) where a Cluster of Tree stumps Left in Place After Jetting Operations.

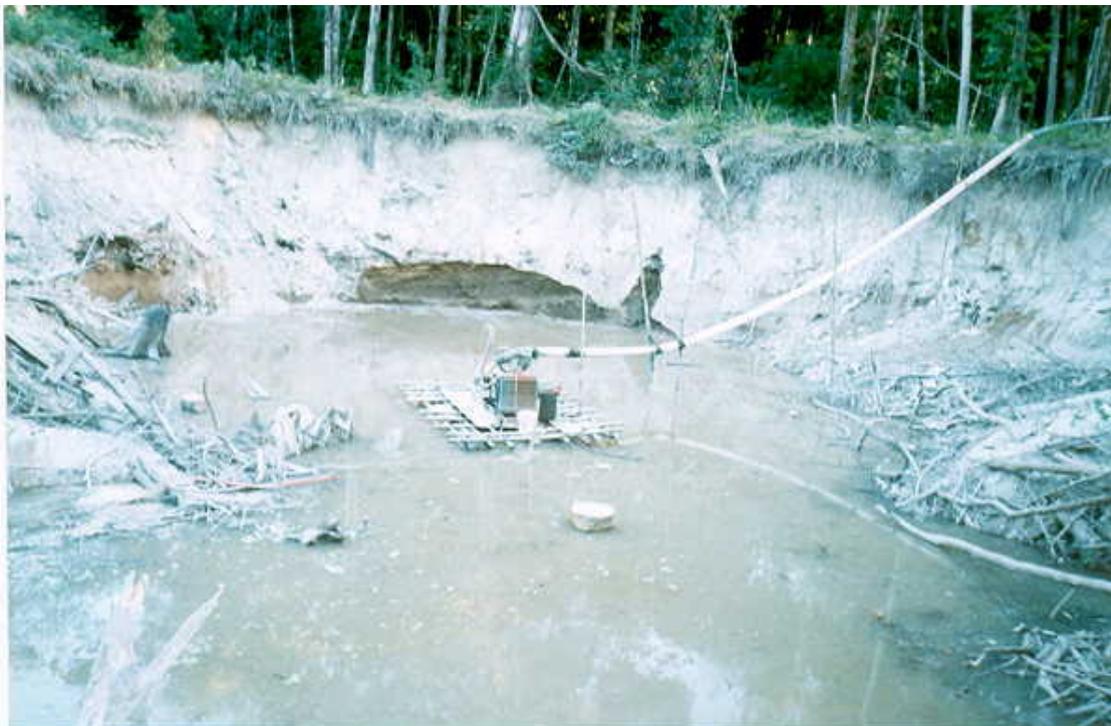
**Photo 4** – Mine Pit of Roger Baxter’s Operations on the Kurupung River Bank. Water Percolating From The River Aid in The Collapsing of Walls of The Thick Overburden Cover.

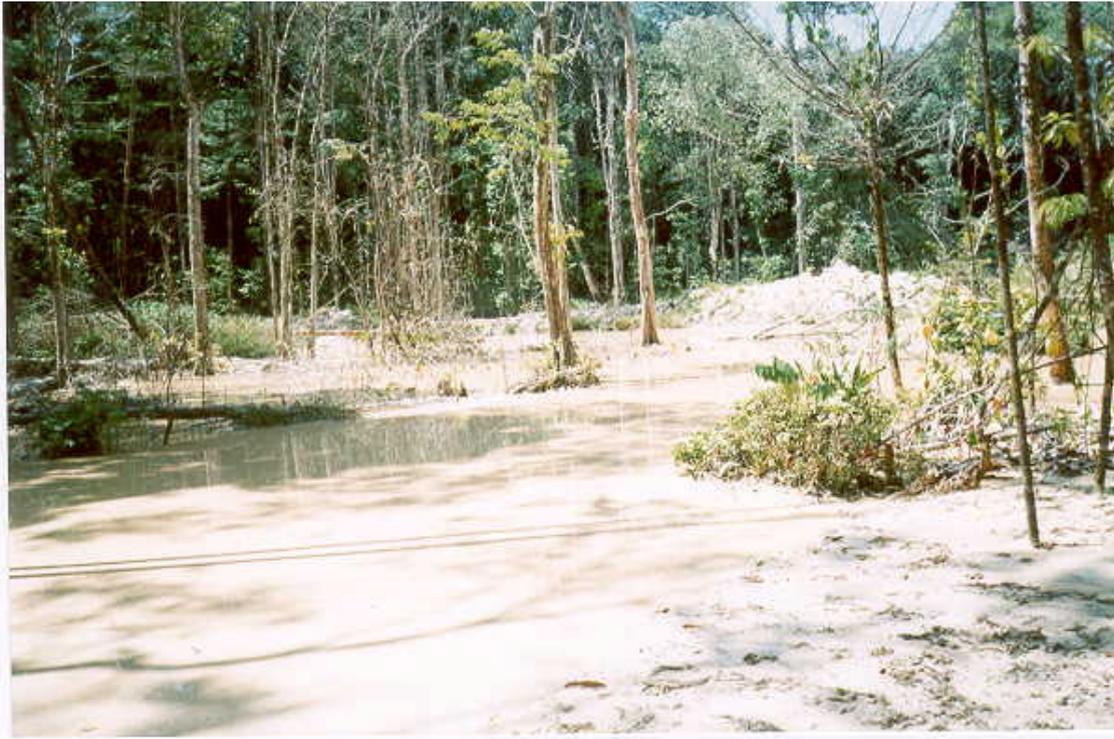
**Photo 5** – Tailings Confinement Dam as Part of The Closed-Circuit Recycled Water System of SANMIK Civil Works Ltd. Operations at Barlow.

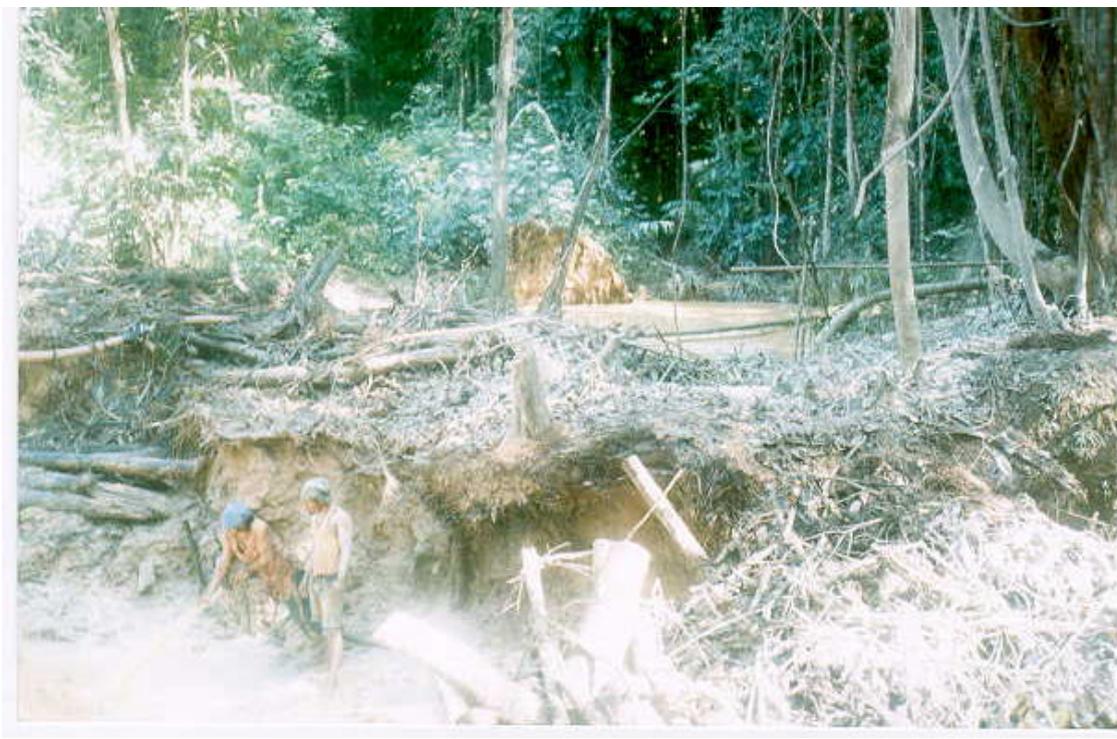
**Photo 6** – Muddy Feed Water of Roy Morrison's Small, Closed-Circuit Operations at Eping. Minimal Water Supply was Noted.

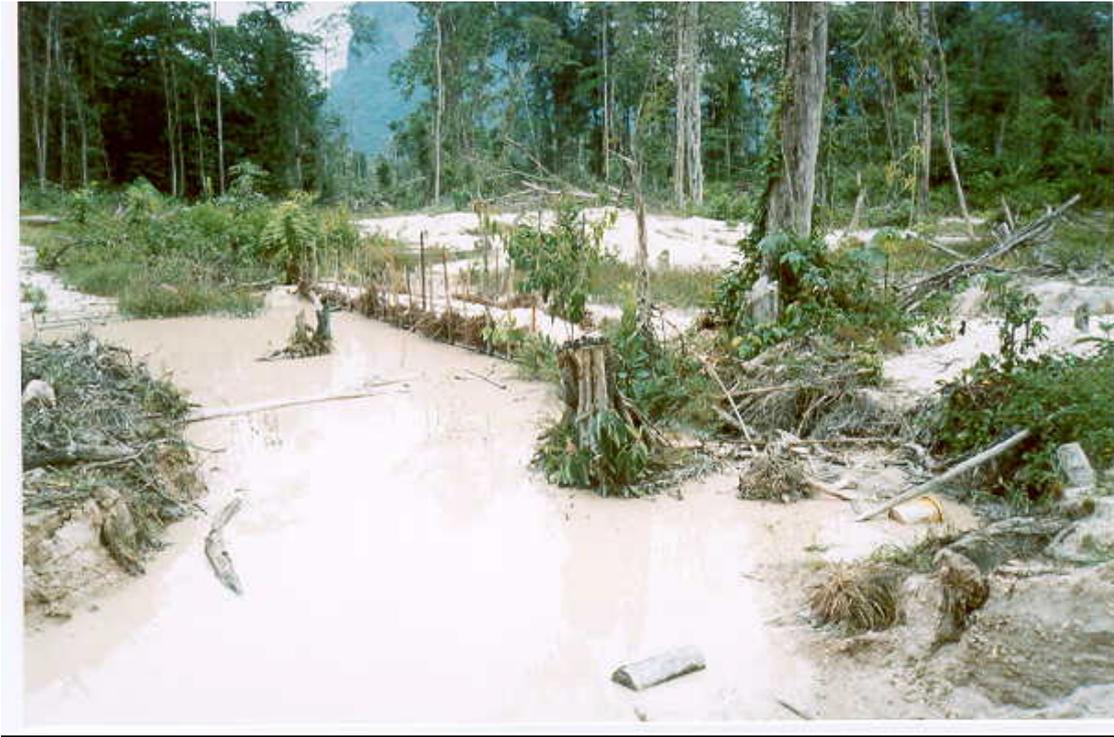
Raimundo DaSilva operated a closed-circuit recycled water mining operation, where the tailings discharge was routed through a filtration dam made of loosely placed fibrous tree roots. The TSS level of 322.5 mg/L at the feed pump was good, given the fact that, the recycle circuit was short (not allowing enough time for solids to settle out), and that

optimum placement of this filter medium would have required some amount of compression of the fibrous matting to increase its ability to trap the suspended solids.

**Photo 7** – Construction of Tailings Confinement Dam From Indigenous Material (as Part of a Closed-Circuit System) at Raimundo DaSilva’s Operations at Upper Takuba Creek.

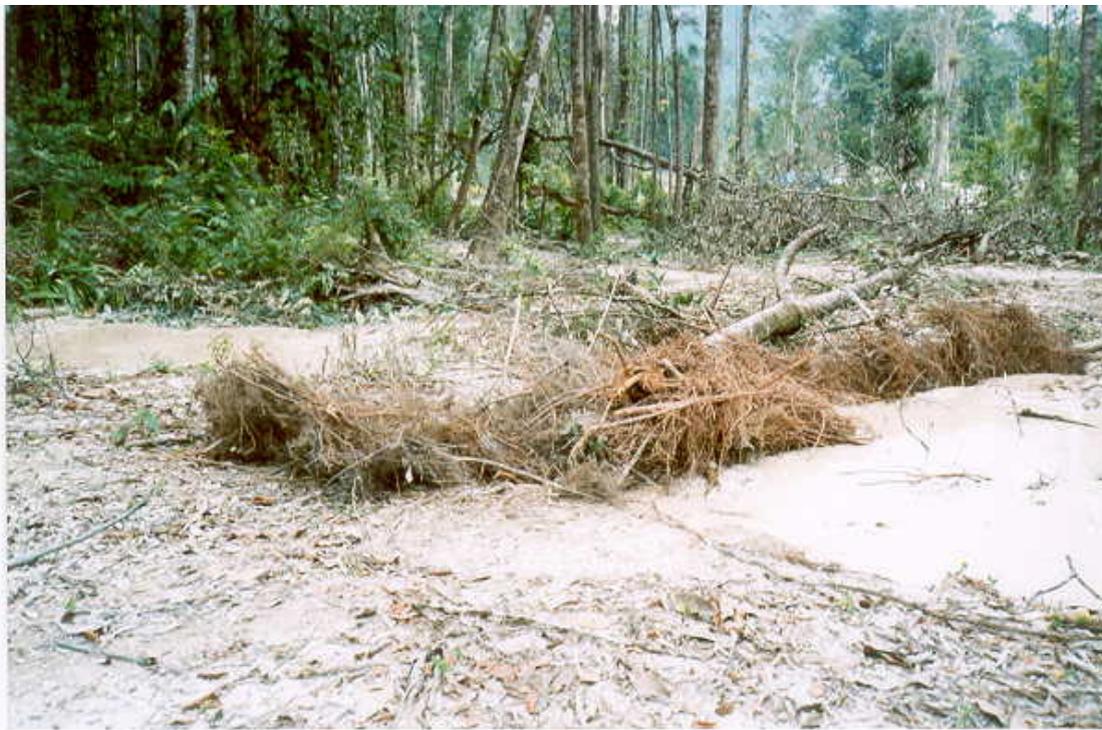
**Photo 8** – A Rapid Filtration Dam, Constructed From Fibrous Roots and supported by Tree Trunks, as Part of a Closed-Circuit Recycled Water System. Raimundo DaSilva’s Operations at Upper Takuba Creek.

*The efficiency of the locally adopted usage of loosely placed “Fibrous Tree Roots” for rapid filtration of tailings effluent, as a part of the closed-circuit recycle water system, could be improved by binding roots in layers (to effectively reduce seepage path, hence trap finer suspended particles).*

*The use of fibrous tree roots as a filtration medium should be investigated to develop its capabilities.*

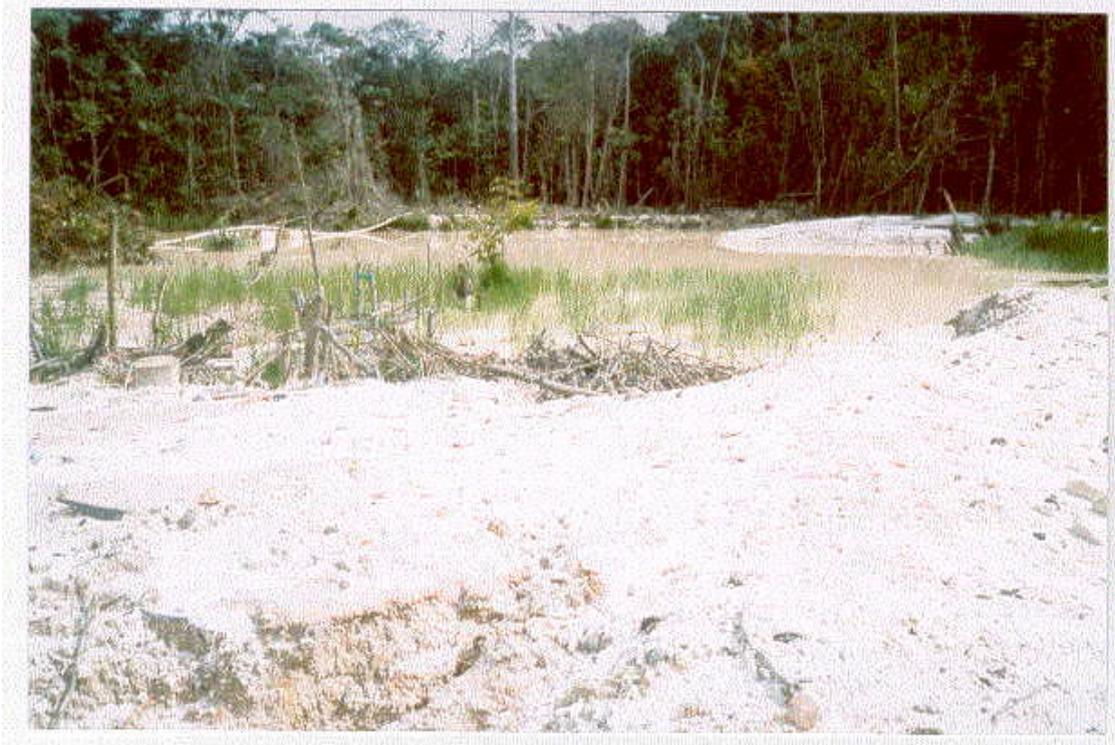
**Photo 9** – Tailings to be Routed Through a Patch of Grass to Aid in Filtration and Settlement of Tailings Solids. DeAssis Lopes' Operations at Barlow.

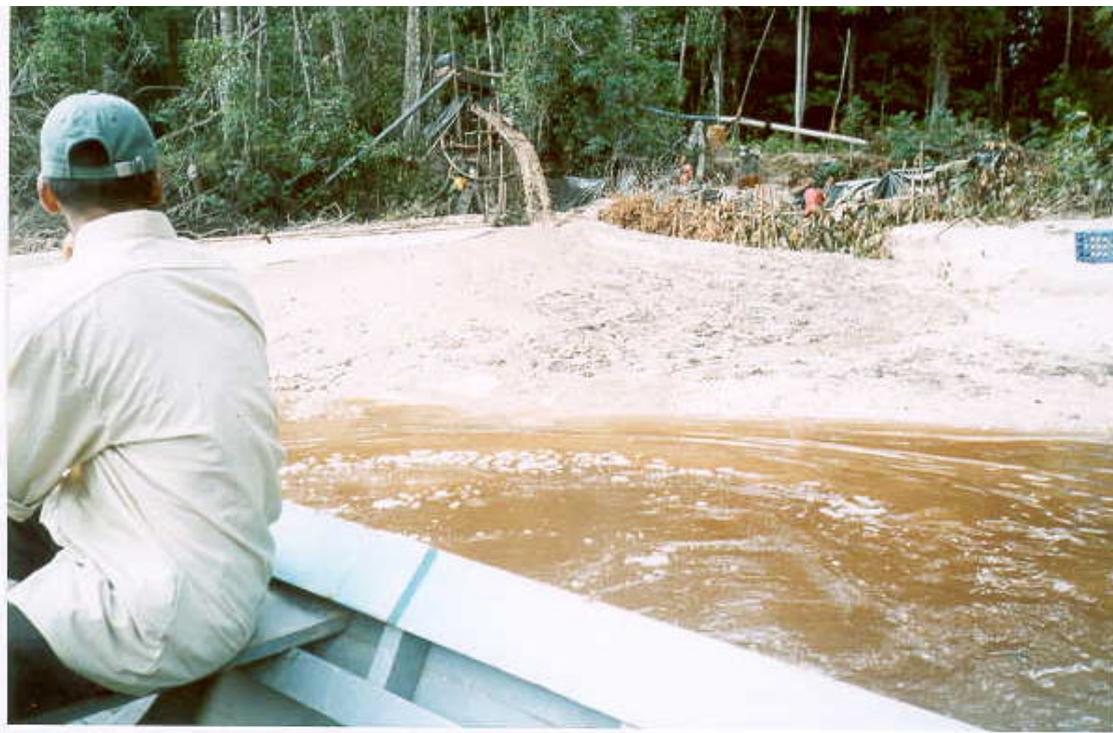
**Photo 10** – Tailings Discharged Directly into the Kurupung River by Roger Baxter's Operations.

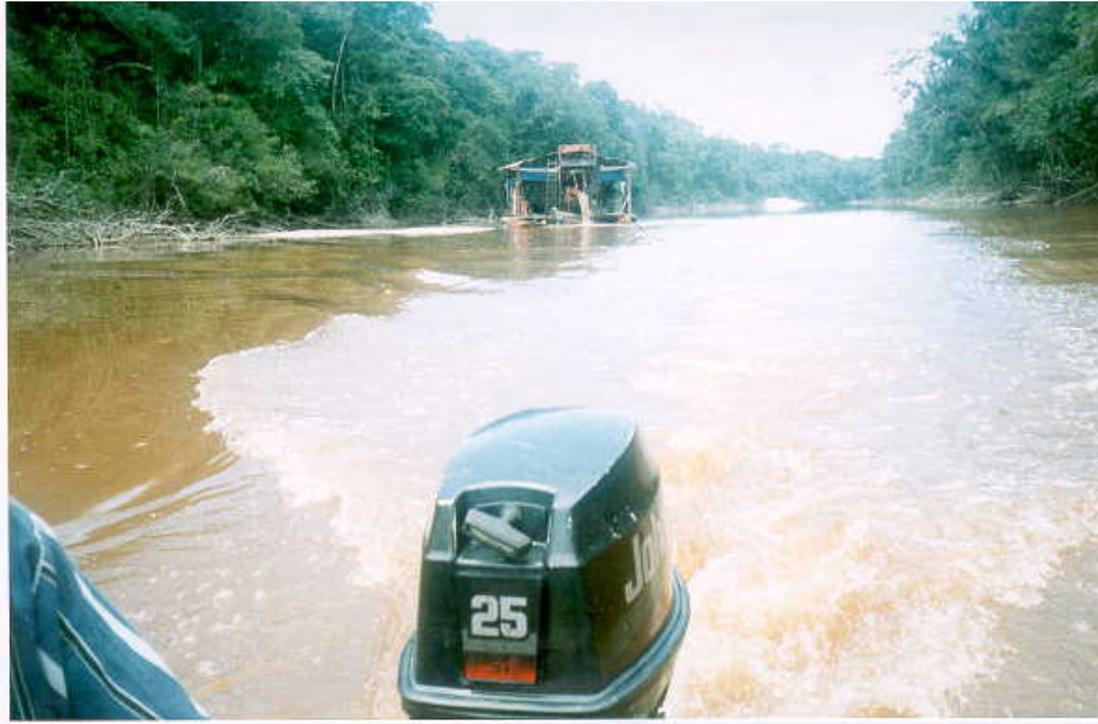
Improper placement and sizing of tailings piles could and invariably lead to the encroachment of the river channel, with the resulting negative effect on river navigation. The encroachment of the river channel by tailings from river dredging operations could be prevented by:

**Photo 11** – Improper Positioning of River Dredge (Tailings Discharge Angled Towards River Channel) Renude Deluz’s Operations, Kurupung River.

**Sequencing:** Sequentially dredging from the riverbank, with the discharge angled towards the bank, while progressing towards the channel (from one bank then the other), will allow the creation of tailings piles in the same sequence.

**Placement:** With the current configuration of rivers dredges (that is, short, rear end discharge), placement of tailings close to the riverbanks could only be achieved by proper sequencing of dredging operations, in conjunction with angling of discharge ends towards the riverbanks. *Alternatively, the utilization of “Extended Floating Discharge Pipes” which will allow flexibility in placement of tailings discharge is recommended.*

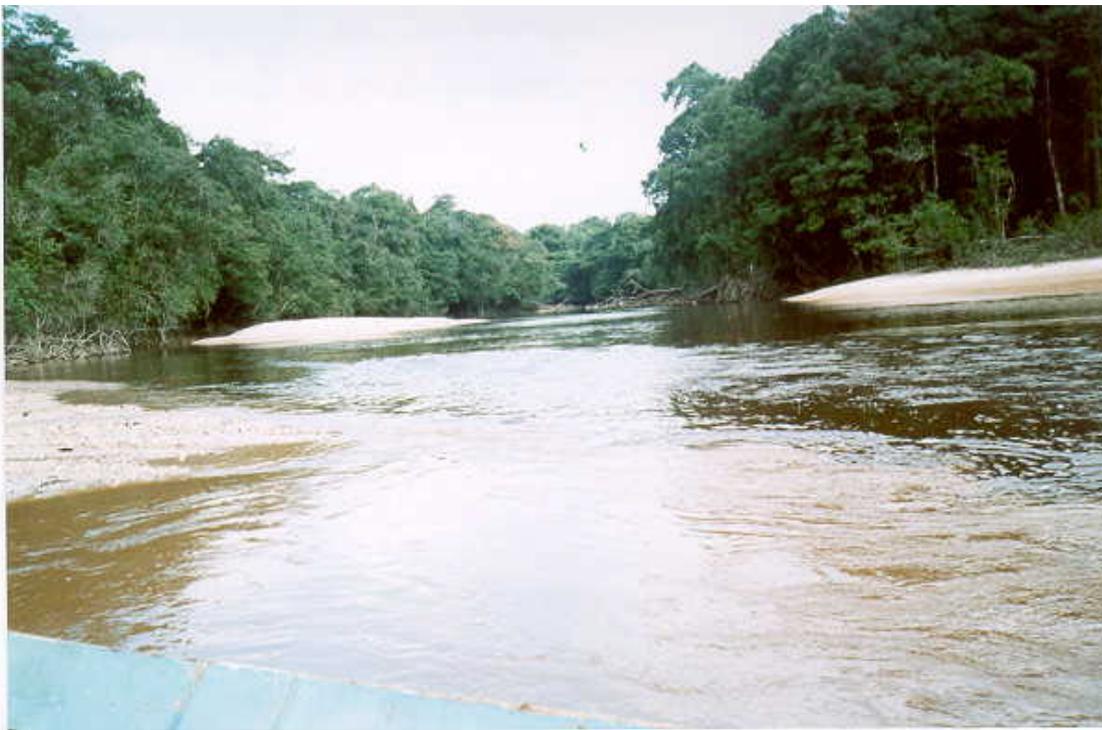
Apart from the visible scars, tailings piles, which encroached on the river channels posed serious navigational difficulties, with resultant safety and economic consequences on the riverain and mining fraternity.

**Photo 12** – Narrowing of River Channel by Tailings Solids from Previous River Dredging Operations. (Kurupung River).

Regulations, which hold operators of river dredges responsible for clearing the channel of the river worked within their claim, should be enacted or enforced.

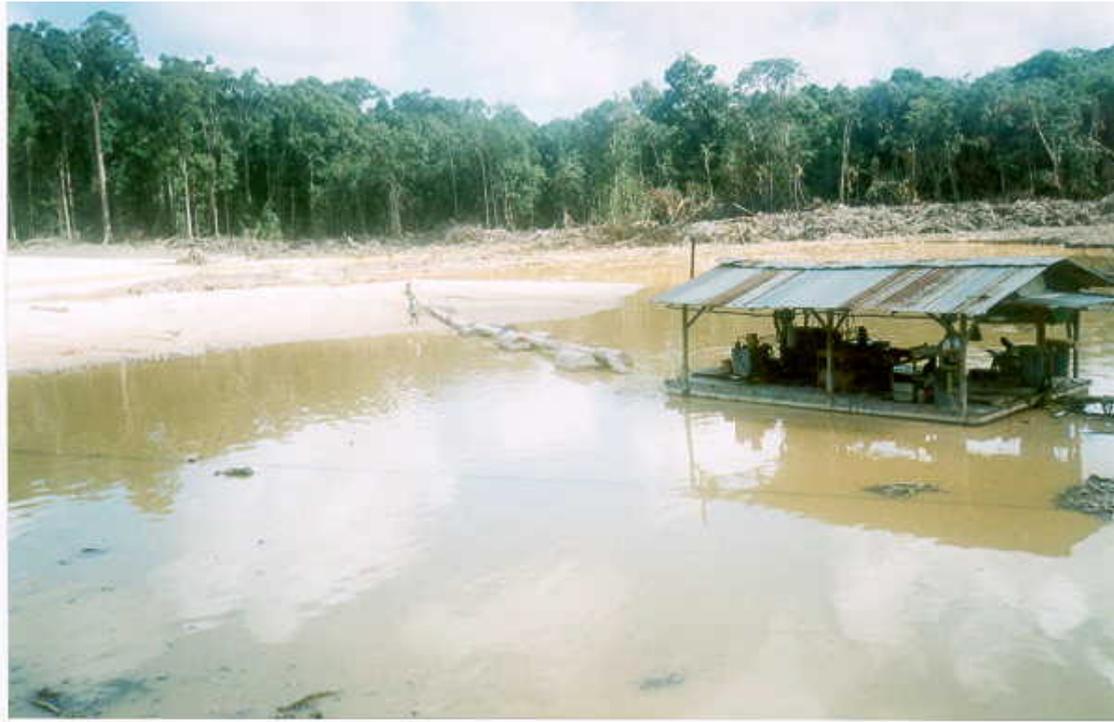
**Photo 13** – Ordinary River Dredge, with Extended Floating Discharge Line, Converted to a “Bailer” for Repositioning Tailings, From Missile Dredges, Away From the Mine Pit. CMC’s Operations at Olive Creek.

The implications of fitting “Extended Floating Tailings Discharge Pipes” to ordinary river dredges should be investigated with the intention of implementing this change. If feasible, this modification could prevent further encroachment of river channels by tailings piles by providing flexibility in placement of tailings discharges.

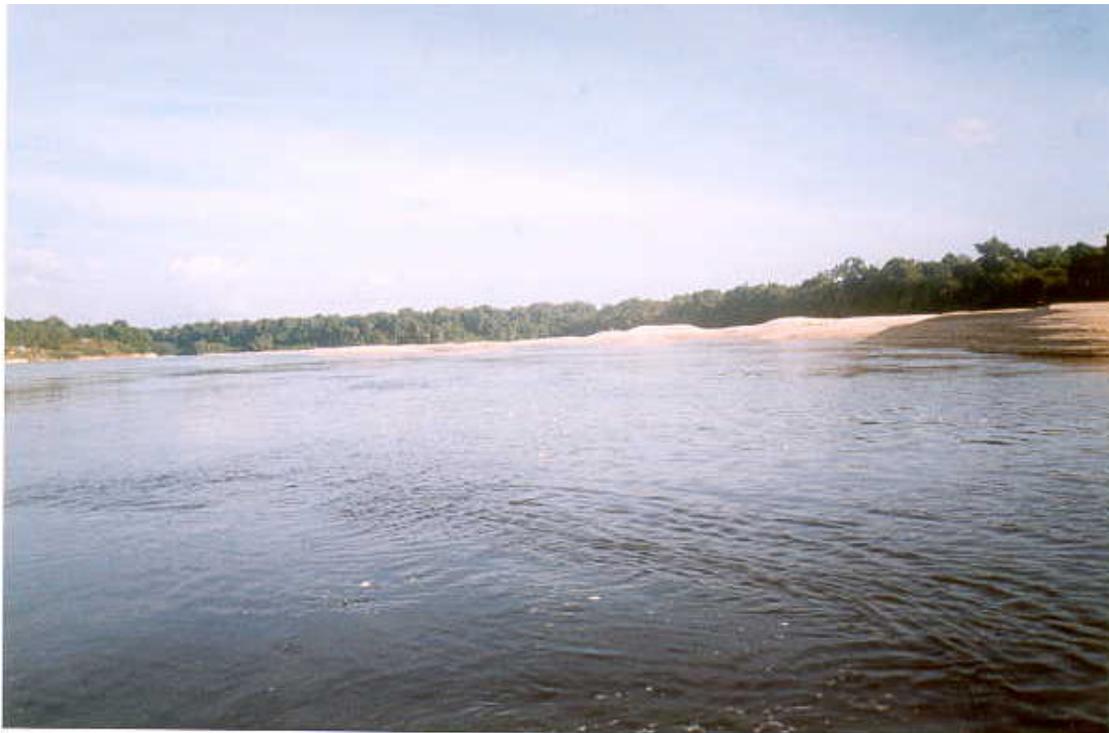
**Photo 14** – Major Series of Tailings Sand/Gravel Barrier Close to Eping River Mouth (Temereng) on the Mazaruni River.

*Issuance of permits to rework tailings piles in portions of rivers, where these pose severe hardship or safety concerns, (and especially, if the dredges would displace the tailings an acceptable distance away) should be encouraged. If economically viable, a programme could be designed to systematically clear critical river channels.*

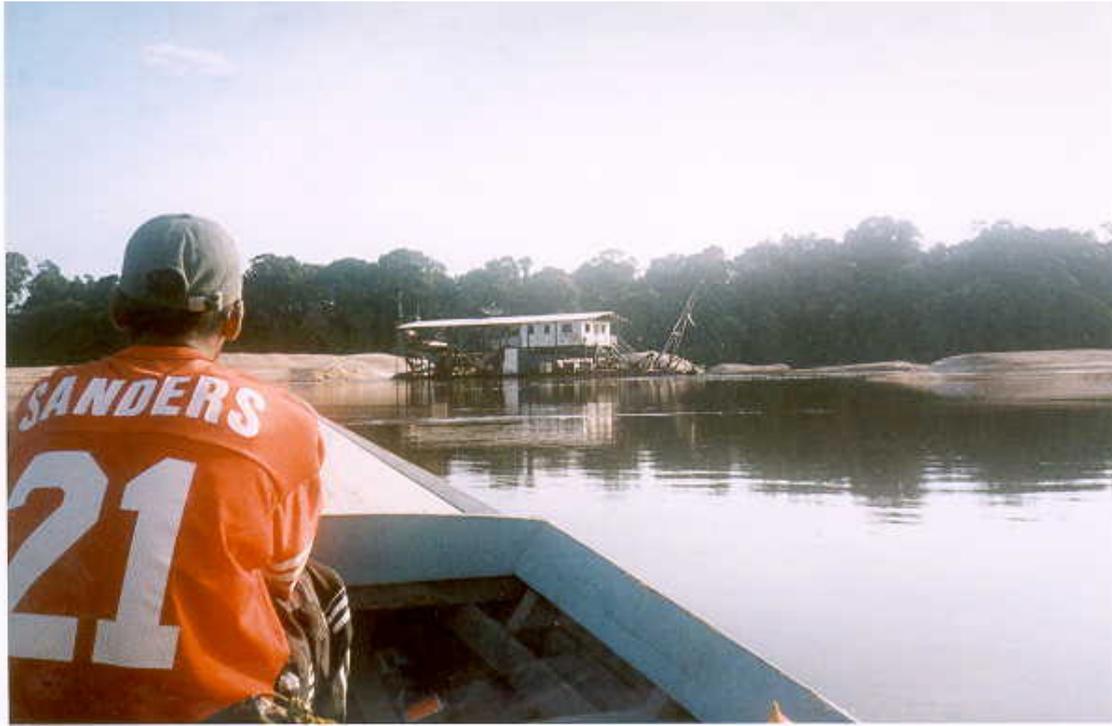
A large river dredge was observed reworking tailings in the vicinity of Temereng on the Mazaruni River. This activity, if completed with a dredge fitted with extended floating discharge pipe, would make a significant impact on the repositioning of tailings piles while effectively clearing the river channel.

**Photo 15** – Reworking of Tailings Deposit by Large River Dredge on the Mazaruni River.

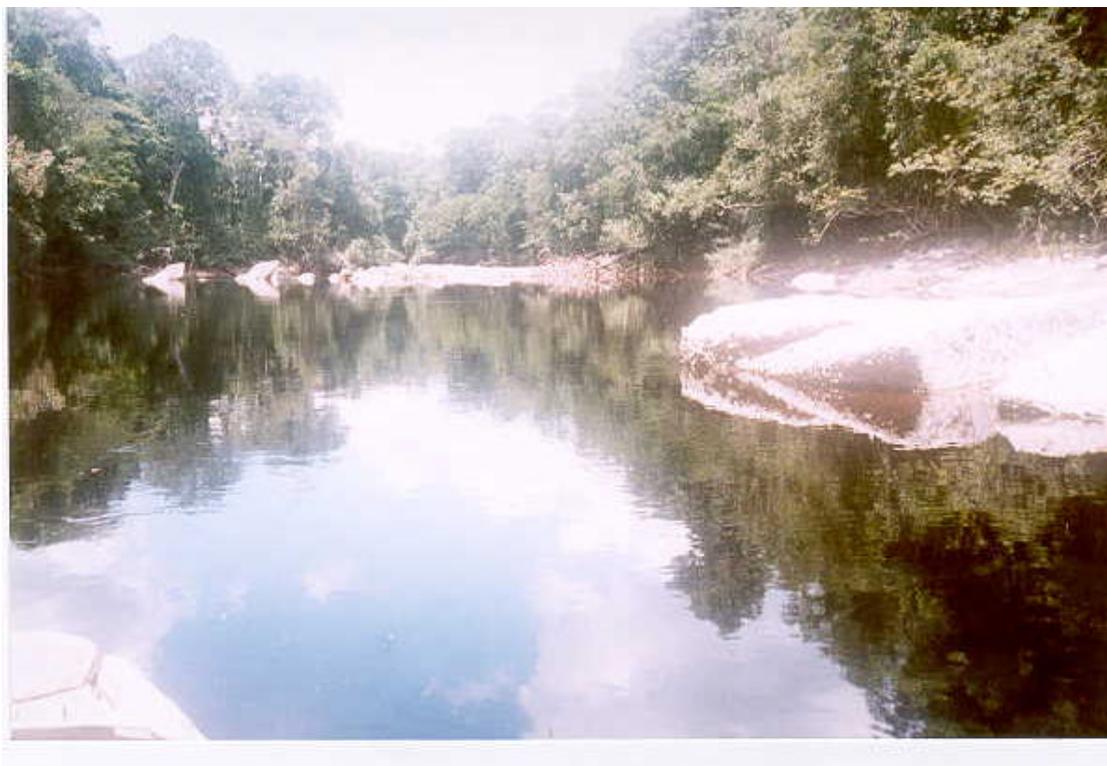
The Upper Kurupung River is not an active mining area but was a location for river dredging activities in the past. Apart from visible tailings piles, which changed the course of or resulted in a shallower river channel, the impact of dredging activities on water quality, fish and animal life was reversible. This was evident from the pristine water, and adequate fish and wildlife available for the community’s ability to exist on.

Observation of the previously dredged Upper Kurupung River indicated that the negative effects of river dredging on the aquatic life and water quality are short-termed, as evident by the pristine water, the abundance of fish, and the surrounding wildlife. However, in the long-term, improper placement of tailings piles (sand bars) results in severe restrictions and hardship on river transportation to riverain communities and the gold and diamond fields, especially in the dry season.

**Photo 16** – Pristine Water of Previously Dredged Area, in the Vicinity of “Crapo Rock”, Upper Kurupung River.

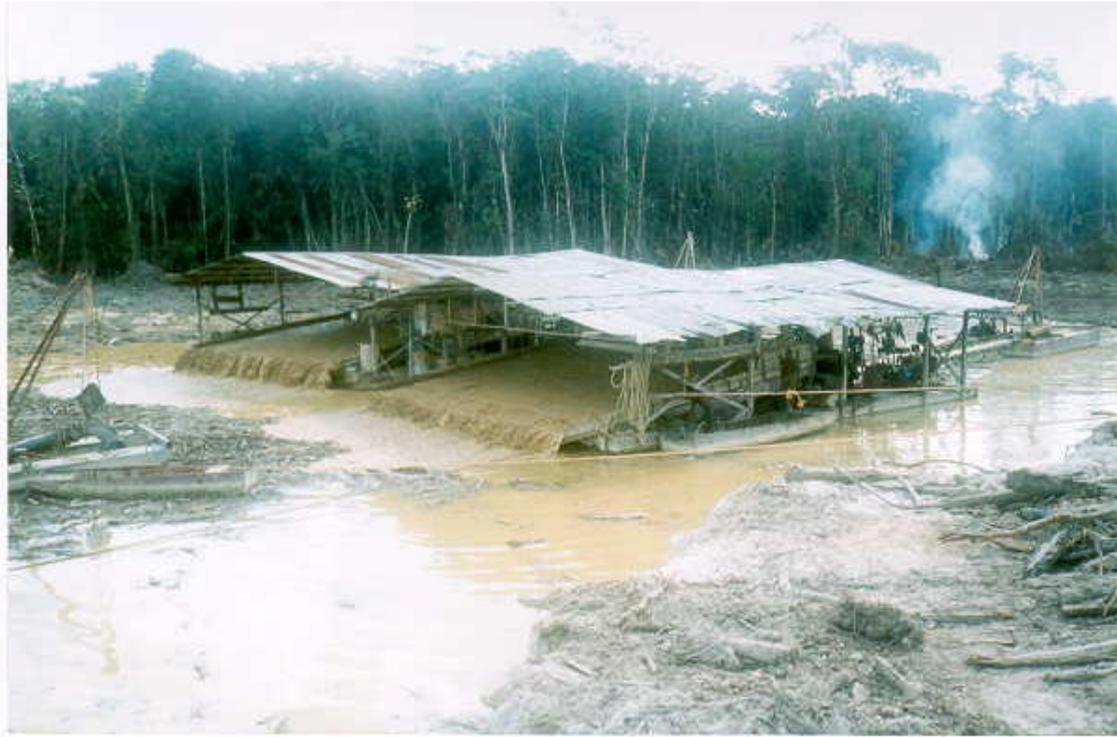
**Photo 17** – Totally Enclosed Operation of Two Missile Dredges, with Wide Sluice Discharges, Operating in Tandem, at Correia Mining Company, Olive Creek.

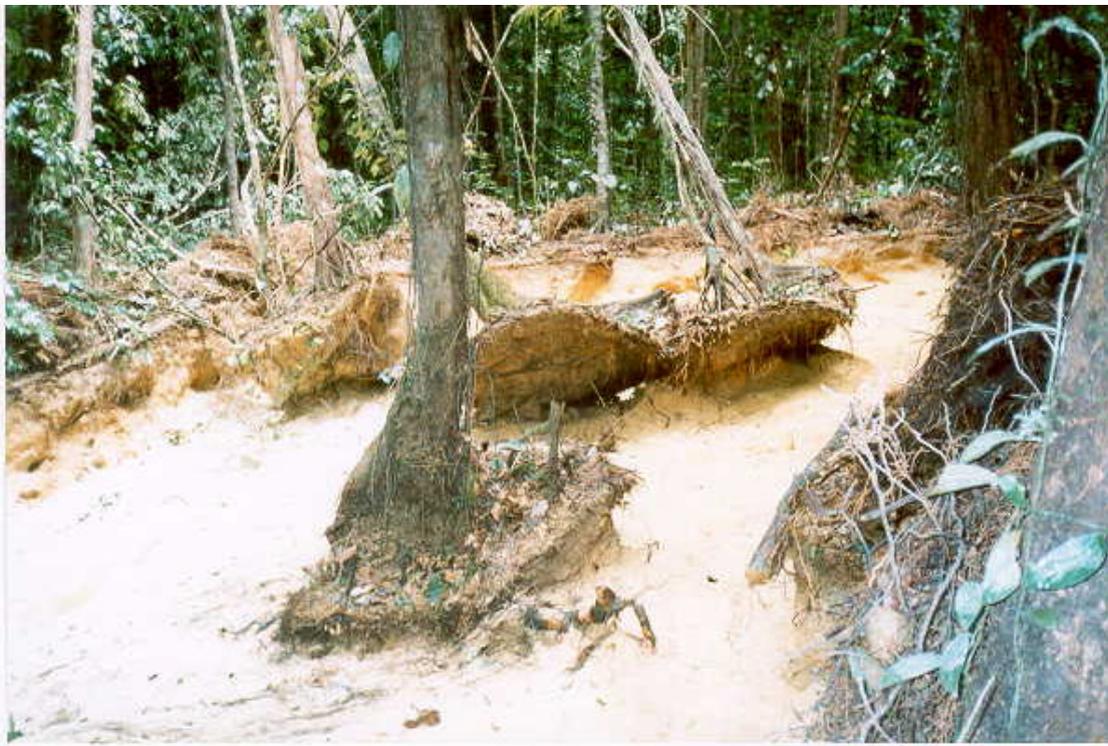
As was the case with previous mining areas visited, instances of undermined trees in current or mined-out areas are a concern.

**Photo 18** – Undermined Trees Left Standing in a Mined-Out Pit, at Chance Creek.

Some input is required from the Occupational Health and Safety Unit pertaining to the above and to the inadequate level of sanitation at Barlow Landing.

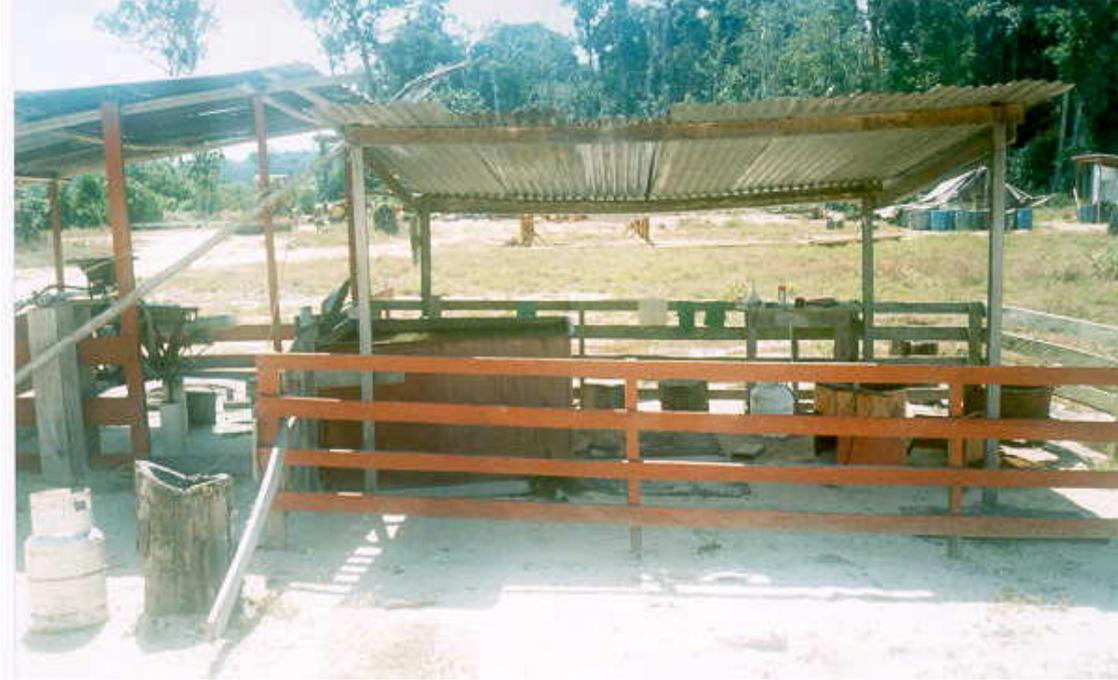
**Photo 19** – Retorting Shed Consisting of Mercury Retort, Jig Box and Shaking Table for Proper Processing of Gold Amalgam and Black Sands. (CMC’s Operations at Olive Creek).
