GENCAPD PROJECT

MINERS' ENVIRONMENTAL OFFICER'S REPORT
On
FIELD TRIP TO MAHDIA MINING DISTRICT
10 June to 16 June 2003

By
Lloyd Stephen

November 2003
Georgetown

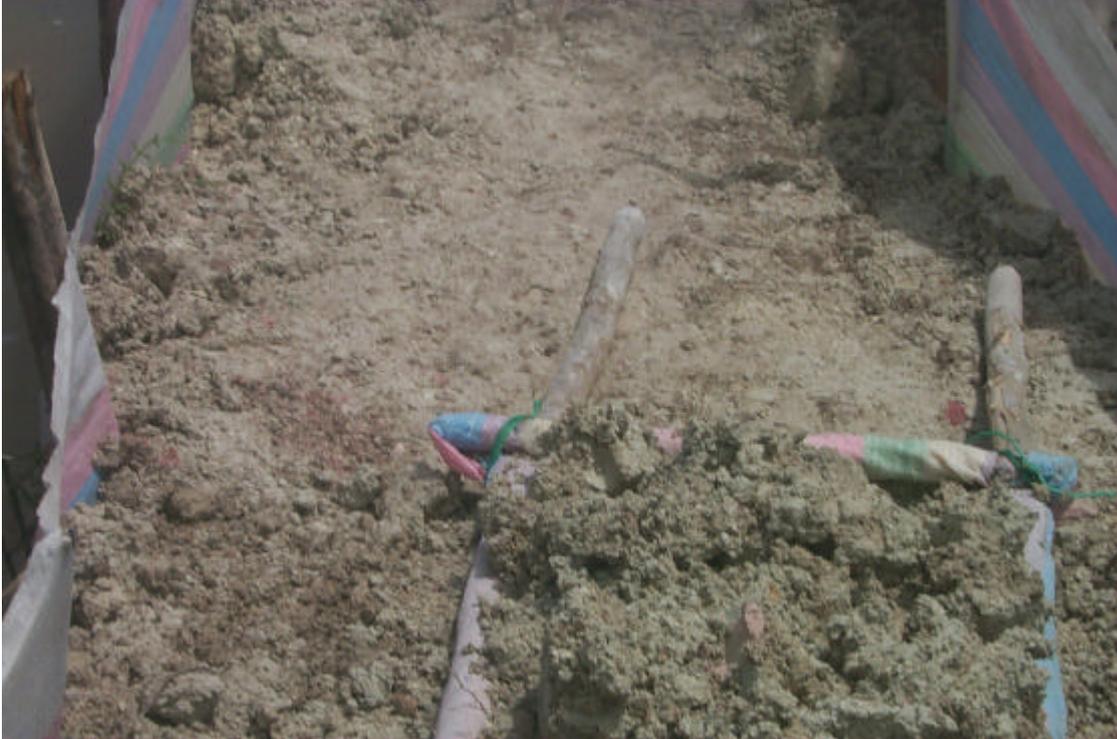
Since the core material was manually placed, inadequate compaction was only achieved by the weight of the material and workers traversing over this core. This lack of compaction resulted in saturation of the core by the percolation of tailings effluent through the core.

Photo 1 - GGMC's EXPERIMENTAL DAM- Core Material Manually Placed

- Excavation of a shallow “cut-off” trench throughout the length of the dam before placement of the core material, in-order to increase the resistance to the lateral pressure of the tailings effluent.
- Extending a portion of the slit-fencing material within the cut-off trench such that it is anchored below the weight of the core fill.
- Improved anchoring of the silt-fences by driving the stakes, used to pin them, deeper into the base.
- The greatest deficiency in the construction this dam was the lack of a realistic means of compacting the dam. Given time and manpower, manual tamping of fill material is one crude alternative under this scenario.

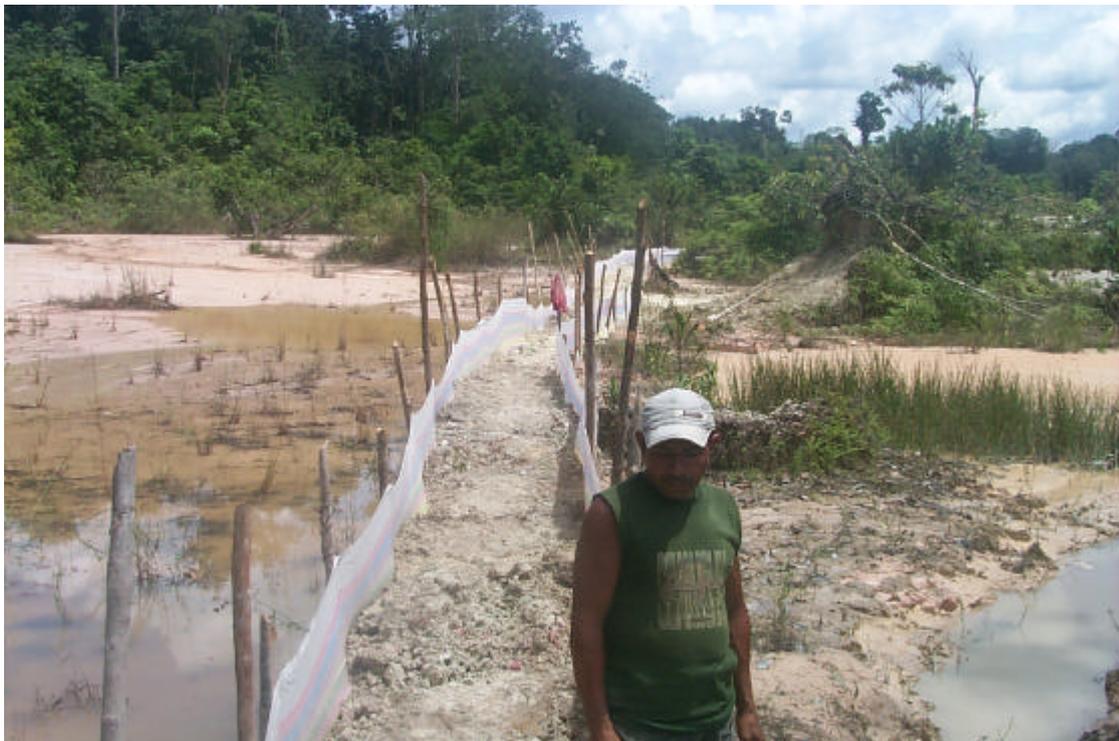
Core material was placed and confined between the filter fences, with special efforts made to prevent failure at the abutments with the high grounds.

Available clay, clayey-sand material, which some gravel inclusions was utilized as the core material. The manual method of excavating and transporting the core material over uneven terrain resulted in the critical criterion for selection of the core material to be best material at the closest location.

Photo 2 - GGMC's EXPERIMENTAL DAM- Core Fill Between Filter Linings

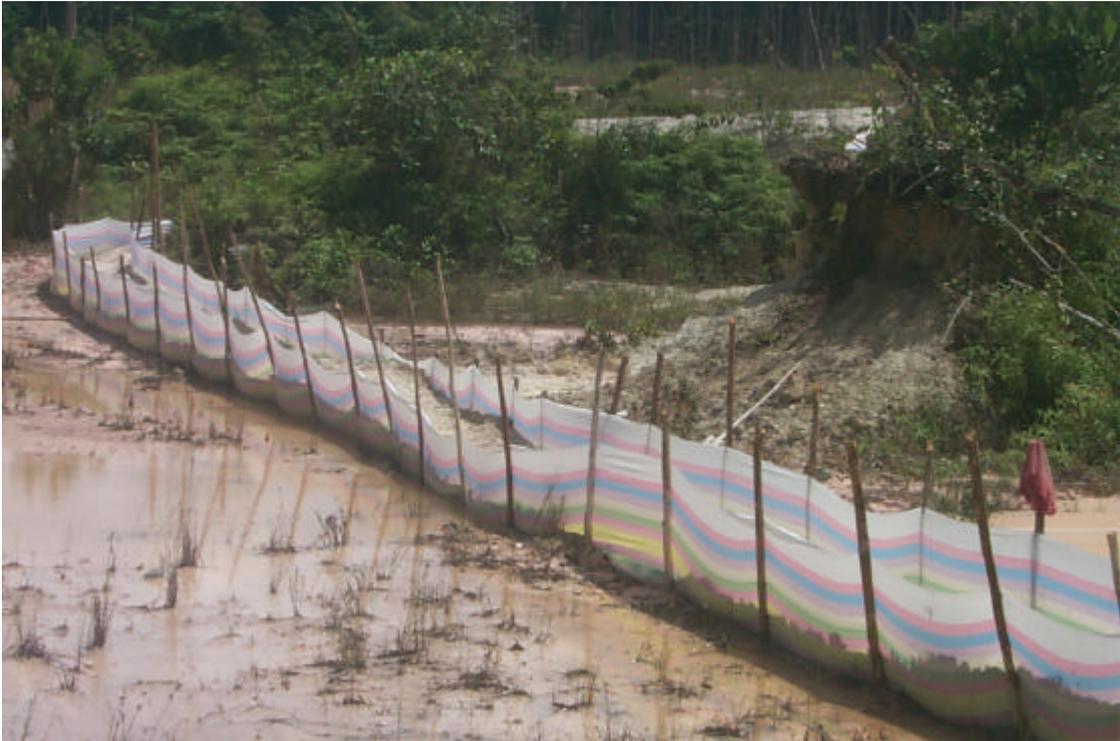
Two sheets of locally manufactured synthetic silt fence material were pinned, in vertically parallel rows by wooden stakes, to bridge the flat between adjacent higher grounds which defined the impoundment area.

Photo 3 - GGMC's EXPERIMENTAL DAM - Filter Linings Pinned by Wooden Stakes

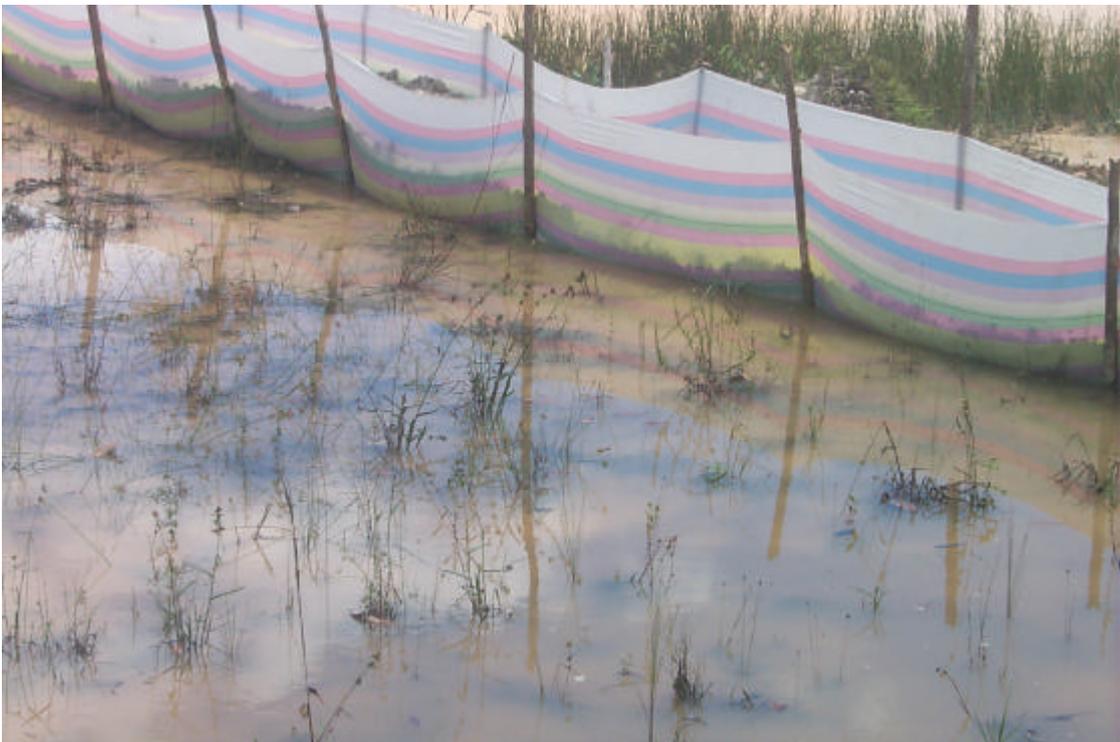
There were evidences of slight bulging of the dam under the lateral pressures of the retained tailings effluent. This condition could have been improved by:

Photo 4 - GGMC's EXPERIMENTAL DAM - Water Trapped Behind Dam
